## General Information

| Make | Toyota | Model | Avanza |
| Registration No. | DAU9629 | Chassis No. | MHKM5FF3FLK006120 |

## Body / Panel Condition

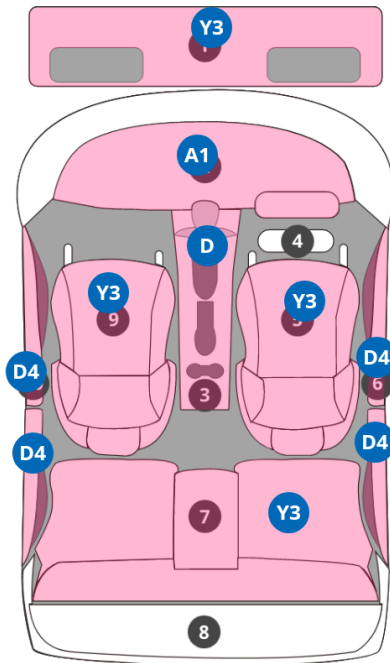
| Interior Evaluation : <b>E</b> | Exterior Evaluation : <b>D</b> |
|---|---|
| <p><b>Remarks</b></p> <p>(R) Front Seat - Grime - Medium / Rear Seat - Grime - Medium / Overall Interior - Worn as per age - Yes / (R) Rear Trim - Worked - Large / Ceiling - Grime - Medium / (L) Rear Trim - Worked - Large / (L) Front Trim - Worked - Large / (R) Front Trim - Worked - Large / Console, Switches, Vents - Traces of Adhesive Tape - Yes / (L) Front Seat - Grime - Medium / Dashboard - Worn, Scratch, Cut, Crack - Minimal</p> | <p><b>Remarks</b></p> <p>(R) Front Door - Repair Traces - Yes / (R) Front Fender - Repair Traces - Yes / Bonnet - Repair Traces - Yes / (L) Front Fender - Repair Traces - Yes / (L) Front Door - Repair Traces - Yes / (L) Rear Door - Repair Traces - Yes / (L) Rear Fender - Repair Traces - Yes / Trunk Hood, Rear Gate - Repair Traces - Yes / (R) Rear Fender - Repair Traces - Yes / (R) Rear Door - Repair Traces - Yes / Roof - Repair Traces - Yes / Overall Exterior - Full Re-Paint in same color - Yes / (R) Front Fender, Molding - Crack, Gap - Medium / (R) Mirror - Scratch - Small / (R) Front Door, Molding - Scratch - Minimal / (R) Rear Door, Molding - Scratch - Small / (R) Step, In-panel, Side Spoiler - Scratch - Medium / (R) Rear Fender, Molding - Scratch - Small / Rear Bumper, Lamps, Panels - Crack, Gap - Small / Trunk Hood, Rear Gate - Crack, Gap - Small / (L) Rear Fender, Molding - Scratch - Small / (L) Rear Door, Molding - Scratch - Minimal / (L) Front Door, Molding - Scratch &amp; Dent - Small / (L) Mirror - Scratch - Small / (L) Front Fender, Molding - Scratch - Minimal / Front Bumper, Grille, Lamps - Scratch &amp; Dent - Large / Roof - Scratch - Minimal / Bonnet, Headlight - Scratch - Minimal / Member (Bolted) - Dent - Yes</p> |
