## General Information

| Make | Toyota | Model | Vios |
| YOM | 2024 | Mileage | 1,234 |
| Registration No. | NHR 5401 | Chassis No. | PA1B18F30P4229758 |

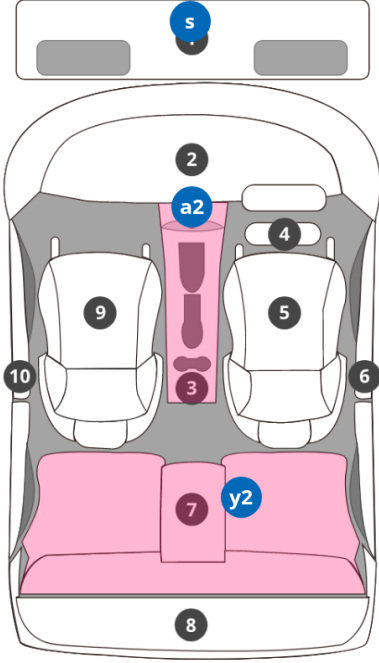
| <b>Interior Evaluation :</b> <b>B</b> | <b>Exterior Evaluation :</b> <b>B</b> |
| <b>Remarks</b><br>Console, Switches, Vents - Worn, Scratch, Cut, Crack - Small / Overall Interior - Smell - Yes / Rear Seat - Grime - Small | <b>Remarks</b><br>Front Bumper, Grille, Lamps - Scratch - Small / (L) Front Door, Molding - Scratch - Minimal / (L) Rear Door, Molding - Scratch & Dent - Minimal / Rear Bumper, Lamps, Panels - Scratch - Medium / Roof - Dent - Small / (R) Rear Fender, Molding - Scratch - Small / (R) Rear Door, Molding - Scratch - Small / (R) Front Door, Molding - Scratch - Minimal / (R) Front Fender, Molding - Crack, Gap - Small / (L) Front Fender, Molding - Scratch - Small |

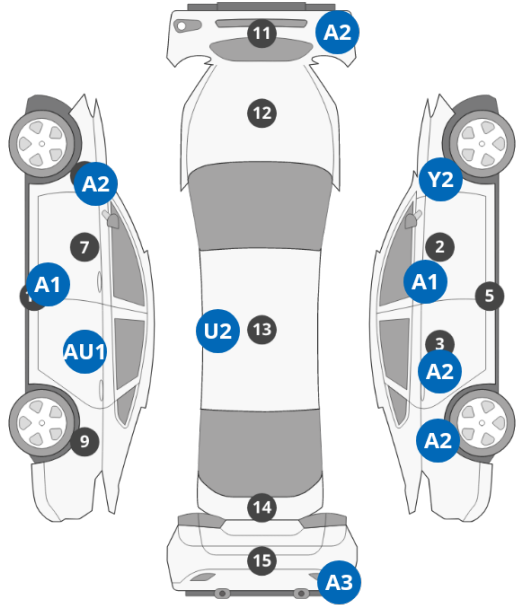
| swirlmarks and hairline scratches around the exterior.No user manual, warranty booklet and tools. |
