## General Information

| Make | Toyota | Model | Vios |
| YOM | 2020 | Odo Meter Reading | 28,073 |

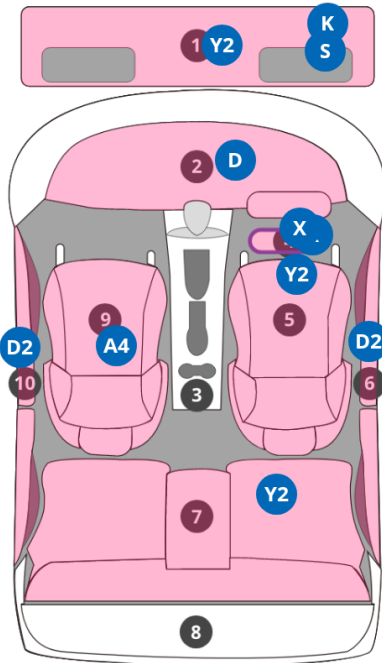
| Interior Evaluation : <b>C</b> | Exterior Evaluation : <b>E</b> |
| <p><b>Remarks</b></p> <p>(L) Front Floor Mat - Missing - Yes / (R) Front Floor Mat - Missing - Yes / Ceiling - Grime - Small / Overall Interior - Smell - Yes / Overall Interior - Animal Hair - Yes / Dashboard - Traces of Adhesive Tape - Yes / (L) Front Trim - Worked - Small / (R) Front Trim - Worked - Small / Rear Seat - Grime - Small / (R) Front Seat - Grime - Small / (L) Front Seat - Cut, Crack - Large</p> | <p><b>Remarks</b></p> <p>(L) Rear Door, Molding - Scratch &amp; Dent - Small / (L) Rear Fender, Molding - Dent - Medium / (L) Front Door, Molding - Scratch - Medium / (L) Step, In-panel, Side Spoiler - Scratch &amp; Dent - Small / (L) Front Fender, Molding - Scratch - Small / Member (Bolted) - Dent - Yes / Front Bumper, Grille, Lamps - Scratch - Small / (R) Front Fender, Molding - Scratch &amp; Dent - Medium / (R) Front Door, Molding - Scratch &amp; Dent - Large / (R) Rear Fender, Molding - Scratch &amp; Dent - Medium / (R) Rear Door, Molding - Scratch - Small / Rear Bumper, Lamps, Panels - Scratch - Small / Trunk Hood, Rear Gate - Scratch &amp; Dent - Small / Roof - Scratch - Small / Bonnet, Headlight - Scratch - Small</p> |

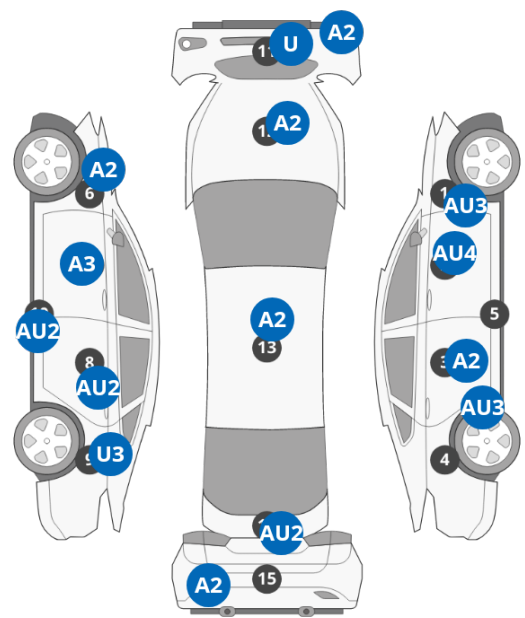
| Inspector Notes |
|---|
| with LTO plate, Spare tire. no warranty booklet, Jack and Tools , Crack tail light and scratch headlight and tail light, right door unusual sound when you open, possible flooded. |
