## General Information

| Make | Toyota | Model | Hilux |

## Body / Panel Condition

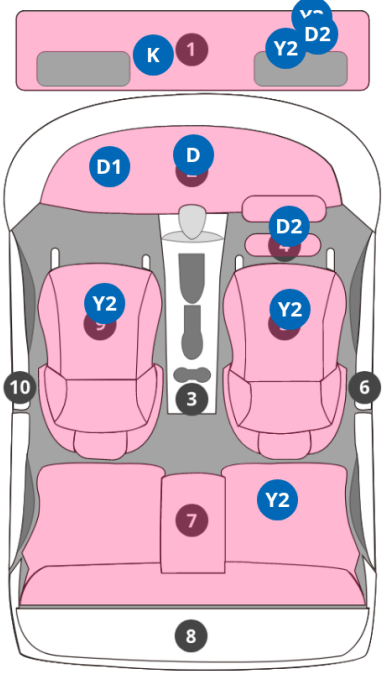
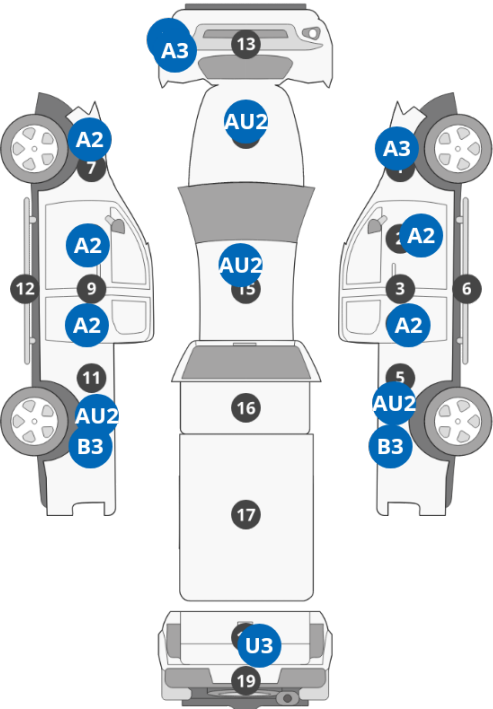
| Interior Evaluation : <b>C</b> | Exterior Evaluation : <b>E</b> |
|---|---|
| <p><b>a</b> : Cut, Fray <b>d</b> : Loose, Deformed <b>k</b> : Animal Hair <b>s</b> : Smell <b>t</b> : Cigarette Burns <b>x</b> : Defective <b>y</b> : Stain</p> | <p><b>A</b> : Scratch <b>AU</b> : Scratch &amp; Dent <b>B</b> : Modified <b>C</b> : Corrosion <b>G</b> : Stone chip <b>P</b> : Faded <b>S</b> : Rust <b>SC</b> : Rust &amp; Corrosion <b>U</b> : Dent <b>X</b> : Defective <b>Y</b> : Crack, Gap</p> |
| <p><b>Remarks</b></p> <p>(L) Front Floor Mat - Worked - Small / Ceiling - Grime - Medium / Overall Interior - Animal Hair - Yes / Sunvisor, Sunglass Holder - Worked - Small / Sunvisor, Sunglass Holder - Grime - Small / Rear Seat - Grime - Small / (R) Front Seat - Grime - Small / (L) Front Seat - Grime - Small / Dashboard - Traces of Adhesive Tape - Yes / Glove Box - Worked - Minimal</p> | <p><b>Remarks</b></p> <p>Member (Bolted) - Dent - Yes / Front Bumper, Grille, Lamps - Scratch - Medium / (L) Front Fender, Molding - Scratch - Small / (L) Front Door, Molding - Scratch - Small / (L) Rear Door, Molding - Scratch - Small / (L) Side Gate - Scratch &amp; Dent - Small / Rear Gate - Dent - Medium / (R) Side Gate - Scratch &amp; Dent - Small / (R) Rear Door, Molding - Scratch - Small / (R) Front Door, Molding - Scratch - Small / (R) Front Fender, Molding - Scratch - Medium / Bonnet, Headlight - Scratch &amp; Dent - Small / Roof - Scratch &amp; Dent - Small / (R) Side Gate - Modified - Medium / (L) Side Gate - Modified - Medium</p> |
