## General Information

| Make | Suzuki | Model | APV |
| YOM | 2024 | Odo Meter Reading | 4,303 |
| Registration No. | NEY5504 | Chassis No. | MHYDN71V7SJ400555 |

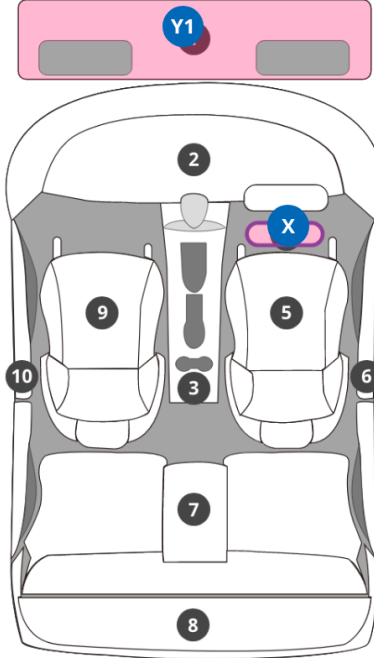
| Interior Evaluation : <span style="color: red; font-weight: bold; font-size: 1.2em;">B</span> | Exterior Evaluation : <span style="color: red; font-weight: bold; font-size: 1.2em;">C</span> |
| <p><b>Remarks</b></p> <p>(L) Front Floor Mat - Missing - Yes / Mat Other - Missing - Yes / Ceiling - Grime - Minimal</p> | <p><b>Remarks</b></p> <p>(R) Front Fender, Molding - Scratch - Minimal / (R) Front Door, Molding - Scratch - Minimal / (R) Rear Door, Molding - Scratch - Minimal / (R) Rear Fender, Molding - Scratch - Minimal / Rear Bumper, Lamps, Panels - Scratch &amp; Dent - Medium / Trunk Hood, Rear Gate - Scratch - Minimal / (L) Rear Fender, Molding - Scratch - Small / (L) Step, In-panel, Side Spoiler - Scratch - Small / (L) Rear Door, Molding - Dent - Small / (L) Front Door, Molding - Scratch - Minimal / (L) Front Fender, Molding - Scratch - Minimal / Front Bumper, Grille, Lamps - Scratch - Small / Front Panel - Scratch - Small / Roof - Dent - Medium</p> |
