## General Information

| Make | Toyota | Model | Fortuner |
| YOM | 2024 | Odo Meter Reading | 13,572 |

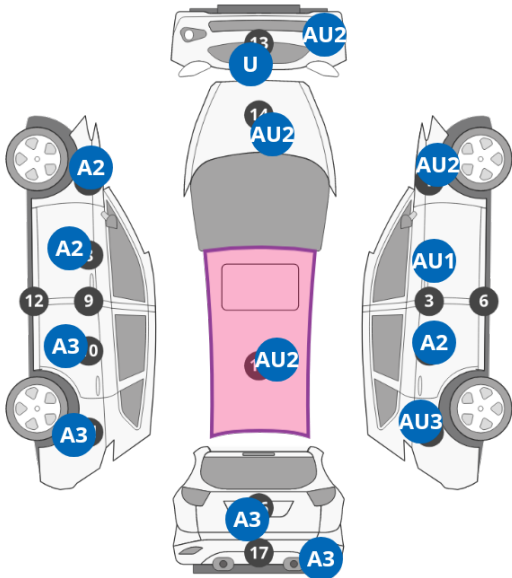
| <div>Interior Evaluation :</div> <div>D</div> <div> </div> <div> <div>a : Cut, Fray</div> <div>d : Loose, Deformed</div> <div>k : Animal Hair</div> <div>s : Smell</div> <div>t : Cigarette Burns</div> <div>x : Defective</div> <div>y : Stain</div> </div> | <div>Exterior Evaluation :</div> <div>D</div> <div> </div> <div> <div>A : Scratch</div> <div>AU : Scratch &amp; Dent</div> <div>B : Modified</div> <div>C : Corrosion</div> <div>G : Stone chip</div> <div>P : Faded</div> <div>S : Rust</div> <div>SC : Rust &amp; Corrosion</div> <div>U : Dent</div> <div>X : Defective</div> <div>Y : Crack, Gap</div> </div> |
| <div>Remarks</div> <div>Trunk Room - Worn, Scratch, Cut, Crack - Small / (R) Front Seat - Grime - Medium / (R) Front Floor Mat - Grime - Medium / (L) Front Seat - Grime - Medium / Rear Seat - Grime - Large / (L) Front Floor Mat - Grime - Medium / (L) Front Trim - Grime - Small / (L) Rear Trim - Grime - Small / (R) Rear Trim - Grime - Small / (R) Front Trim - Grime - Small / Ceiling - Grime - Small / Dashboard - Traces of Adhesive Tape - Yes</div> | <div>Remarks</div> <div>Roof - Repair Traces - Yes / (R) Front Door, Molding - Scratch &amp; Dent - Minimal / (R) Rear Door, Molding - Scratch - Small / (R) Rear Fender, Molding - Scratch &amp; Dent - Medium / Roof - Repair mark - Yes / Trunk Hood, Rear Gate - Scratch - Medium / Rear Bumper, Lamps, Panels - Scratch - Medium / (L) Rear Fender, Molding - Scratch - Medium / (L) Rear Door, Molding - Scratch - Medium / Front Bumper, Grille, Lamps - Scratch &amp; Dent - Small / Member (Bolted) - Dent - Yes / (L) Front Door, Molding - Scratch - Small / (L) Front Fender, Molding - Scratch - Small / Bonnet, Headlight - Scratch &amp; Dent - Small / (R) Front Fender, Molding - Scratch &amp; Dent - Small / Roof - Scratch &amp; Dent - Small</div> |
