General Information

Make	Toyota	Model	Vios
YOM	2019	Odo Meter Reading	39,997
Registration No.	P1C582	Chassis No.	PA1B18F33K4082539
CC	1.3	Transmission	M/T
Fuel Type	Gas	Type of Body	Sedan
Colour	Black

Body / Panel Condition

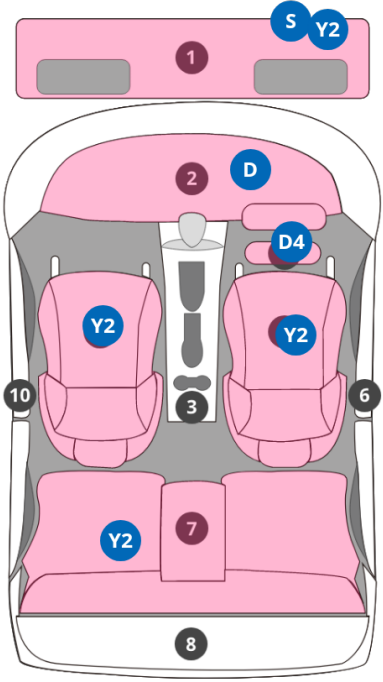
Interior Evaluation : C	Exterior Evaluation : E

<p>a : Cut, Fray d : Loose, Deformed k : Animal Hair s : Smell t : Cigarette Burns x : Defective y : Stain</p>

<p>A : Scratch AU : Scratch & Dent B : Modified C : Corrosion G : Stone chip P : Faded S : Rust SC : Rust & Corrosion U : Dent X : Defective Y : Crack, Gap</p>
<p>Remarks (R) Front Seat - Grime - Small / (L) Front Seat - Grime - Small / Rear Seat - Grime - Small / Dashboard - Traces of Adhesive Tape - Yes / Overall Interior - Smell - Yes / Ceiling - Grime - Small / (L) Front Floor Mat - Worked - Large</p>	<p>Remarks (R) Step - Replaced - Yes / (R) Front Fender - Repair Traces - Yes / (L) Step - Repair Traces - Yes / Roof - Repair Traces - Yes / (L) Step, In-panel, Side Spoiler - Repair mark - Yes / (R) Step, In-panel, Side Spoiler - Repair mark - Yes / Member (Bolted) - Dent - Yes / (R) Step, In-panel, Side Spoiler - Scratch & Dent - Medium / (R) Rear Door, Molding - Repair mark - Yes / (R) Rear Door, Molding - Scratch & Dent - Small / (R) Front Door, Molding - Scratch & Dent - Small / (R) Rear Fender, Molding - Repair mark - Yes / (R) Rear Fender, Molding - Scratch - Small / Trunk Hood, Rear Gate - Dent - Small / (L) Rear Fender, Molding - Scratch & Dent - Medium / Rear Bumper, Lamps, Panels - Crack, Gap - Large / (L) Rear Door, Molding - Repair mark - Yes / (L) Rear Door, Molding - Dent - Medium / (L) Front Door, Molding - Scratch & Dent - Small / (L) Step, In-panel, Side Spoiler - Dent - Small / (L) Front Fender, Molding - Repair mark - Yes / (R) Front Fender, Molding - Repair mark - Yes / (L) Front Fender, Molding - Scratch & Dent - Large / Front Bumper, Grille, Lamps - Scratch & Dent - Medium / (R) Front Fender, Molding - Scratch & Dent - Small / Bonnet, Headlight - Scratch & Dent - Small / Roof - Scratch & Dent - Small</p>
