General Information

Make	Toyota	Model	Vios
YOM	2024	Odo Meter Reading	28,960
Registration No.	DBN8868	Chassis No.	PA1B18F31P4234516
CC	1.3	Transmission	CVT
Fuel Type	Gas	Type of Body	Sedan
Colour	Red

Body / Panel Condition

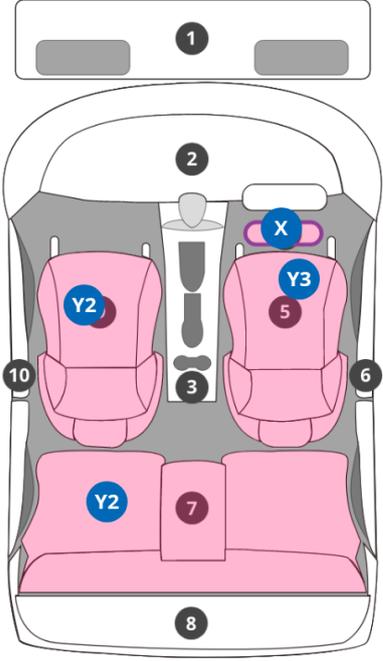
Interior Evaluation : B	Exterior Evaluation : C

<p>a : Cut, Fray d : Loose, Deformed k : Animal Hair s : Smell t : Cigarette Burns x : Defective y : Stain</p>

<p>A : Scratch AU : Scratch & Dent B : Modified C : Corrosion G : Stone chip P : Faded S : Rust SC : Rust & Corrosion U : Dent X : Defective Y : Crack, Gap</p>
<p>Remarks Rear Seat - Grime - Small / (R) Front Seat - Grime - Medium / (L) Front Floor Mat - Missing - Yes / (L) Front Seat - Grime - Small</p>	<p>Remarks (R) Front Fender, Molding - Scratch - Small / (R) Mirror - Scratch - Minimal / (R) Front Door, Molding - Scratch - Small / (R) Step, In-panel, Side Spoiler - Scratch & Dent - Medium / (R) Rear Door, Molding - Scratch - Small / (R) Rear Fender, Molding - Scratch - Small / Rear Bumper, Lamps, Panels - Scratch - Minimal / Trunk Hood, Rear Gate - Scratch - Minimal / (L) Rear Fender, Molding - Scratch - Small / (L) Rear Door, Molding - Scratch - Minimal / (L) Front Door, Molding - Scratch - Minimal / (L) Mirror - Scratch - Small / (L) Front Fender, Molding - Scratch - Minimal / Front Bumper, Grille, Lamps - Scratch - Small / Roof - Scratch - Minimal / Bonnet, Headlight - Scratch - Minimal</p>

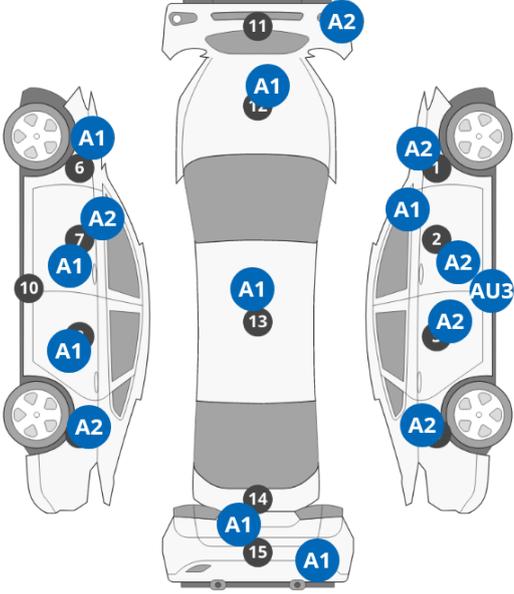
<p>Inspector Notes</p>
<p>No LTO plate, with warranty booklet, with jack and incomplete tools, with spare tire, watermark stain, scratches on tail light and headlight.</p>
