General Information

Make	Mitsubishi	Model	Mirage
YOM	2023	Odo Meter Reading	23,272
Registration No.	EAG1556	Chassis No.	PAEA13TJPPA005183
CC	1.2	Transmission	A/T
Fuel Type	Gas	Type of Body	Sedan
Colour	Gray

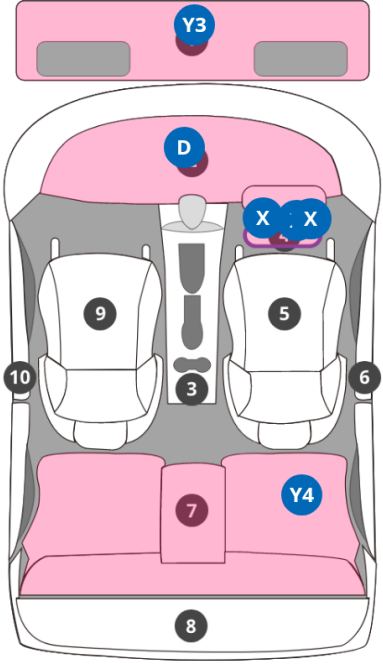
<p>a : Cut, Fray d : Loose, Deformed k : Animal Hair s : Smell t : Cigarette Burns x : Defective y : Stain</p>

<p>A : Scratch AU : Scratch & Dent B : Modified C : Corrosion G : Stone chip P : Faded S : Rust SC : Rust & Corrosion U : Dent X : Defective Y : Crack, Gap</p>
<p>Remarks Dashboard - Traces of Adhesive Tape - Yes / Mat Other - Missing - Yes / (L) Front Floor Mat - Missing - Yes / (R) Front Floor Mat - Missing - Yes / Rear Seat - Grime - Large / Ceiling - Grime - Medium</p>	<p>Remarks (R) Front Door, Molding - Scratch & Dent - Medium / (R) Rear Door, Molding - Scratch & Dent - Large / (R) Rear Fender, Molding - Scratch - Small / Rear Bumper, Lamps, Panels - Scratch & Dent - Large / Trunk Hood, Rear Gate - Scratch & Dent - Small / (L) Rear Fender, Molding - Scratch - Large / (L) Front Door, Molding - Scratch - Small / Bonnet, Headlight - Scratch & Dent - Small / Front Bumper, Grille, Lamps - Scratch & Dent - Small / Roof - Scratch - Small</p>
