## General Information

| Make | Toyota | Model | Innova |

## Body / Panel Condition

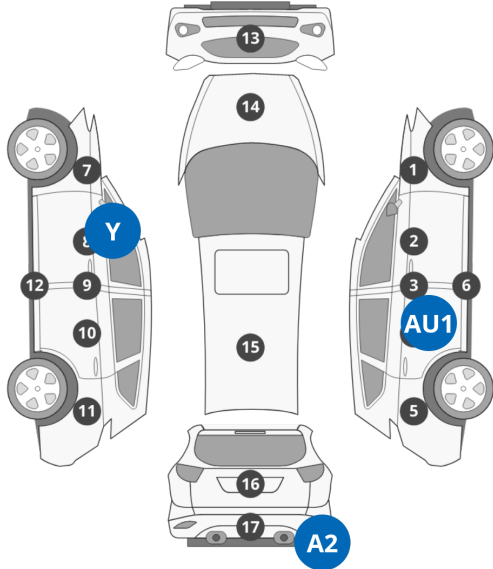
| Interior Evaluation : <span style="color: red; font-weight: bold;">A</span> | Exterior Evaluation : <span style="color: red; font-weight: bold;">C</span> |
| <b>Remarks</b><br>Defects not found | <b>Remarks</b><br>Trunk Hood, Rear Gate - Repair Traces - Yes / (R) Rear Door, Molding - Scratch & Dent - Minimal / (L) Mirror - Crack - Damaged / Rear Bumper, Lamps, Panels - Scratch - Small |

missing right side mirror cover/ with tools and spare tire/ no warranty booklet
