General Information

Make	Toyota	Model	Wigo
YOM	2024	Odo Meter Reading	3,968
Registration No.	CCD2140	Chassis No.	MHKAA1BC8RJ017639
CC	1.0	Transmission	CVT
Fuel Type	Gas	Type of Body	Hatchback
Colour	Gray

Body / Panel Condition

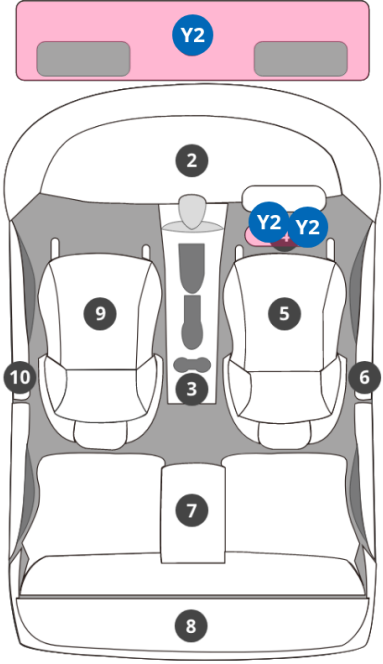
Interior Evaluation : A	Exterior Evaluation : A

<p>a : Cut, Fray d : Loose, Deformed k : Animal Hair s : Smell t : Cigarette Burns x : Defective y : Stain</p>

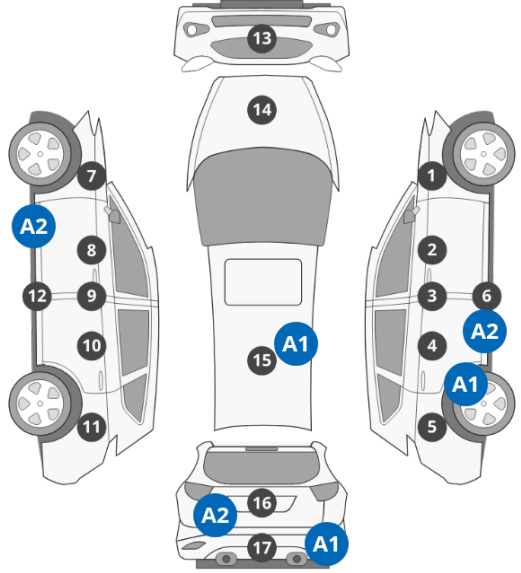
<p>A : Scratch AU : Scratch & Dent B : Modified C : Corrosion G : Stone chip P : Faded S : Rust SC : Rust & Corrosion U : Dent X : Defective Y : Crack, Gap</p>
<p>Remarks Ceiling - Grime - Small / (R) Front Floor Mat - Grime - Small / Mat Other - Grime - Small</p>	<p>Remarks (L) Step, In-panel, Side Spoiler - Scratch - Small / Trunk Hood, Rear Gate - Scratch - Small / Rear Bumper, Lamps, Panels - Scratch - Minimal / Roof - Scratch - Minimal / (R) Rear Fender, Molding - Scratch - Minimal / (R) Step, In-panel, Side Spoiler - Scratch - Small</p>
Frame Evaluation : A	Functional Evaluation : A
<p>Remarks Defects not found</p>	<p>Remarks Defects not found</p>
