## General Information

| Make | Toyota | Model | Vios |
| YOM | 2022 | Odo Meter Reading | 96,946 |
| Registration No. | DAR7752 | Chassis No. | PA1B18F33N4184067 |

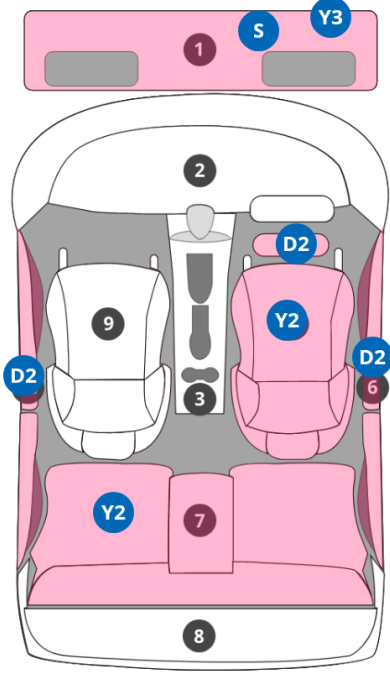
| Interior Evaluation : <b>B</b> | Exterior Evaluation : <b>C</b> |
|---|---|
| <p><b>Remarks</b></p> <p>Overall Interior - Smell - Yes / Ceiling - Grime - Medium / Rear Seat - Grime - Small / (R) Front Seat - Grime - Small / (L) Front Floor Mat - Worked - Small / (L) Front Trim - Worked - Small / (R) Front Trim - Worked - Small</p> | <p><b>Remarks</b></p> <p>(R) Front Fender - Repair Traces - Yes / Bonnet - Repair Traces - Yes / (L) Front Fender - Repair Traces - Yes / (L) Front Door - Repair Traces - Yes / (L) Front Fender, Molding - Repair mark - Yes / Bonnet, Headlight - Repair mark - Yes / (R) Front Fender, Molding - Repair mark - Yes / (L) Rear Door, Molding - Scratch &amp; Dent - Medium / (L) Front Door, Molding - Scratch - Minimal / (L) Front Fender, Molding - Scratch - Small / Bonnet, Headlight - Scratch - Small / Member (Bolted) - Dent - Yes / Front Bumper, Grille, Lamps - Scratch - Small / (R) Front Fender, Molding - Scratch - Minimal / (R) Front Door, Molding - Scratch - Small / (R) Rear Door, Molding - Scratch - Small / (R) Rear Fender, Molding - Scratch &amp; Dent - Minimal / Rear Bumper, Lamps, Panels - Scratch &amp; Dent - Small / Trunk Hood, Rear Gate - Scratch - Small / Roof - Scratch - Minimal</p> |

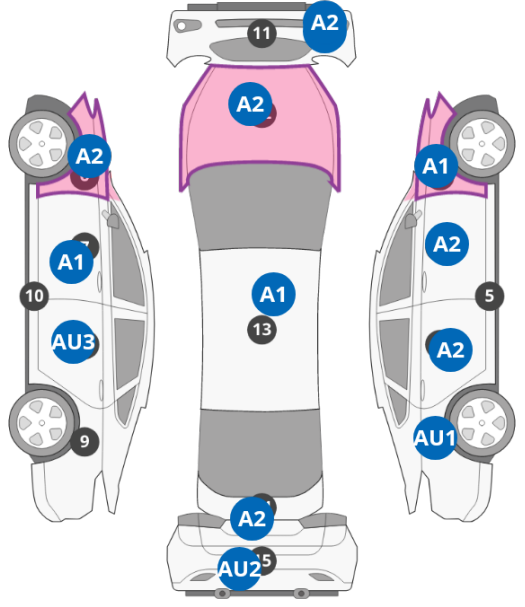
| Inspector Notes |
|---|
| With LTO plate and Sparetire. no Tools and Jack, no warranty booklet, Scratch headlight and tail light. Crack tail light. worn tires, |
