## General Information

| Make | Toyota | Model | Vios |
| YOM | 2024 | Odo Meter Reading | 8,687 |
| Registration No. | DBM6591 | Chassis No. | PA1B18F3R4247076 |

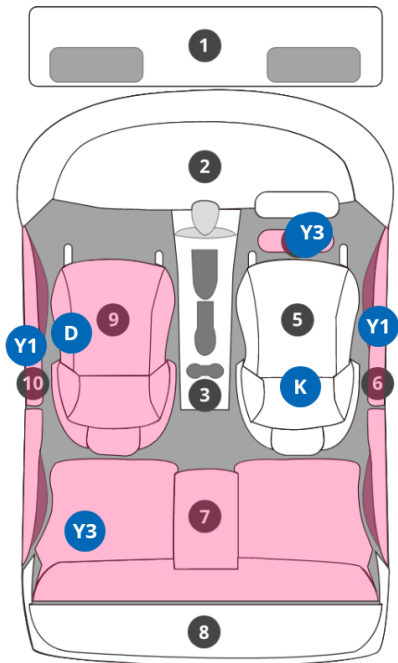
| Interior Evaluation : <b>C</b> | Exterior Evaluation : <b>E</b> |
| <p><b>Remarks</b></p> <p>(R) Front Floor Mat - Grime - Medium / (L) Front Floor Mat - Worked - Large / Mat Other - Grime - Medium / (L) Front Seat - Worn - Yes / Overall Interior - Animal Hair - Yes / Rear Seat - Grime - Medium / (L) Front Trim - Grime - Minimal / (R) Front Trim - Grime - Minimal</p> | <p><b>Remarks</b></p> <p>(L) Rear Fender - Repair Traces - Yes / Trunk Hood, Rear Gate - Repair Traces - Yes / (R) Front Fender, Molding - Scratch &amp; Dent - Small / (R) Front Door, Molding - Scratch - Minimal / (R) Rear Door, Molding - Scratch - Small / (R) Rear Fender, Molding - Scratch - Large / Rear Bumper, Lamps, Panels - Repair mark - Yes / Rear Bumper, Lamps, Panels - Scratch - Small / (L) Mirror - Scratch - Small / (L) Rear Door, Molding - Scratch - Minimal / (L) Front Door, Molding - Scratch - Small / (L) Front Fender, Molding - Scratch - Small / Member (Bolted) - Dent - Yes / Front Bumper, Grille, Lamps - Scratch - Medium / Bonnet, Headlight - Scratch - Medium / (L) Rear Fender, Molding - Crack, Gap - Medium / Roof - Scratch - Medium / Trunk Hood, Rear Gate - Crack, Gap - Large</p> |

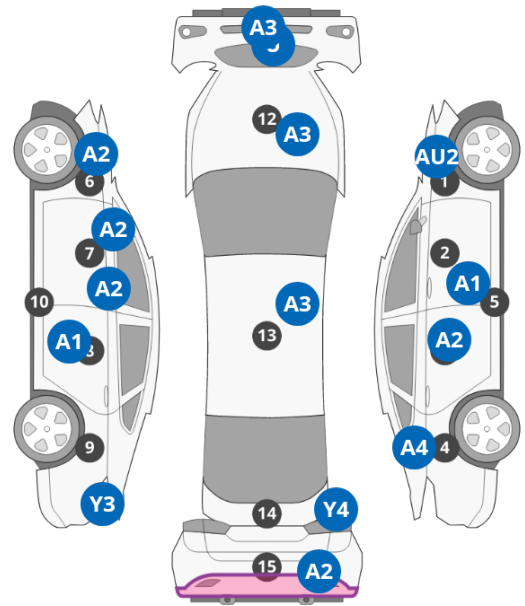
no warranty booklet, with jack and tools, with spare tire and LTO PLATE, scratches on tail light, loose tail light
