## General Information

<b>Make</b>	Toyota	<b>Model</b>	Vios
<b>YOM</b>	2025	<b>Odo Meter Reading</b>	16,732
<b>Registration No.</b>	NKJ4758	<b>Chassis No.</b>	PA1B18F34R4266962
<b>CC</b>	1.3	<b>Transmission</b>	CVT
<b>Fuel Type</b>	Gas	<b>Type of Body</b>	Sedan
<b>Colour</b>	Blue

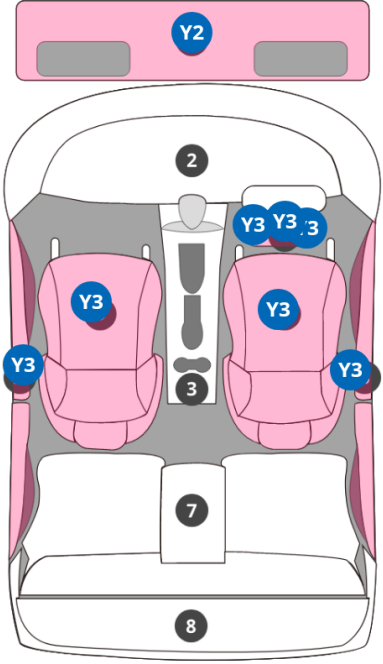
<b>Interior Evaluation :</b> <span style="float: right; color: red; font-weight: bold;">C</span>	<b>Exterior Evaluation :</b> <span style="float: right; color: red; font-weight: bold;">B</span>

<p><b>a</b> : Cut, Fray <b>d</b> : Loose, Deformed <b>k</b> : Animal Hair <b>s</b> : Smell <b>t</b> : Cigarette Burns <b>x</b> : Defective <b>y</b> : Stain</p>

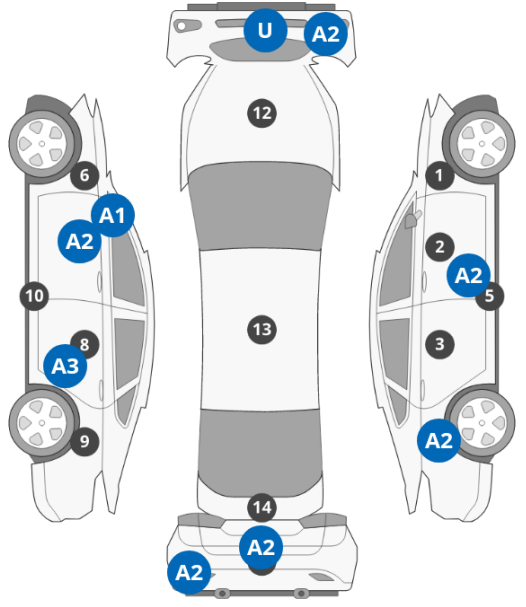
<p><b>A</b> : Scratch <b>AU</b> : Scratch &amp; Dent <b>B</b> : Modified <b>C</b> : Corrosion <b>G</b> : Stone chip <b>P</b> : Faded <b>S</b> : Rust <b>SC</b> : Rust &amp; Corrosion <b>U</b> : Dent <b>X</b> : Defective <b>Y</b> : Crack, Gap</p>
<p><b>Remarks</b> Ceiling - Grime - Small / (R) Front Trim - Grime - Medium / (R) Front Floor Mat - Grime - Medium / (R) Front Seat - Grime - Medium / Mat Other - Grime - Medium / (L) Front Trim - Grime - Medium / (L) Front Floor Mat - Grime - Medium / (L) Front Seat - Grime - Medium</p>	<p><b>Remarks</b> (L) Mirror - Scratch - Minimal / Member (Bolted) - Dent - Yes / (L) Rear Door, Molding - Scratch - Medium / (L) Front Door, Molding - Scratch - Small / (R) Rear Fender, Molding - Scratch - Small / (R) Front Door, Molding - Scratch - Small / Rear Bumper, Lamps, Panels - Scratch - Small / Trunk Hood, Rear Gate - Scratch - Small / Front Bumper, Grille, Lamps - Scratch - Small</p>
