General Information

Make	Toyota	Model	Wigo
YOM	2021	Odo Meter Reading	43,005
Registration No.	NFC3409	Chassis No.	MHKA4DF5FMJ053950
CC	1.0	Transmission	A/T
Fuel Type	Gas	Type of Body	Hatchback
Colour	White

Body / Panel Condition

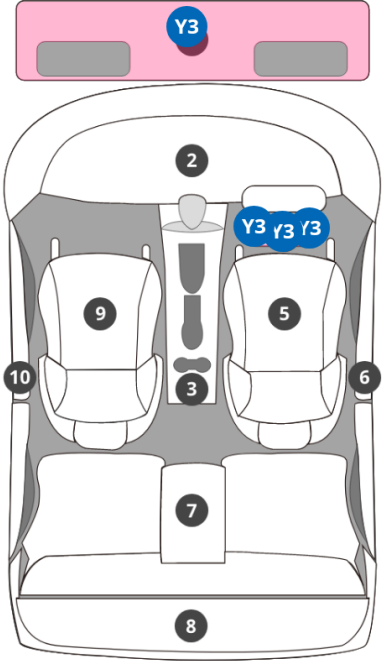
Interior Evaluation : B	Exterior Evaluation : E

<p>a : Cut, Fray d : Loose, Deformed k : Animal Hair s : Smell t : Cigarette Burns x : Defective y : Stain</p>

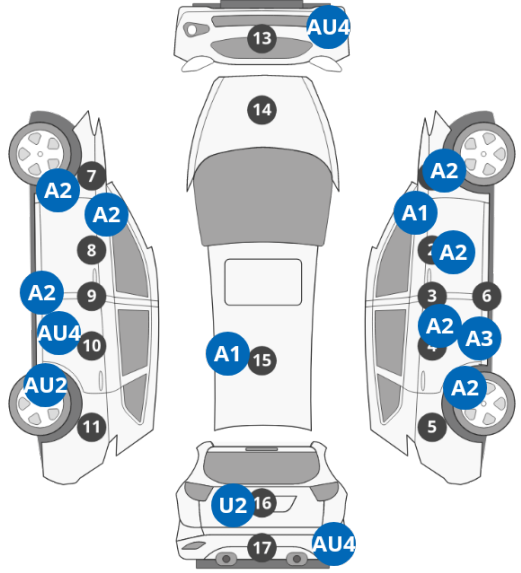
<p>A : Scratch AU : Scratch & Dent B : Modified C : Corrosion G : Stone chip P : Faded S : Rust SC : Rust & Corrosion U : Dent X : Defective Y : Crack, Gap</p>
<p>Remarks (R) Front Floor Mat - Grime - Medium / Mat Other - Grime - Medium / (L) Front Floor Mat - Grime - Medium / Ceiling - Grime - Medium</p>	<p>Remarks (L) Front Fender - Repair Traces - Yes / (L) Front Door - Repair Traces - Yes / (R) Mirror - Scratch - Minimal / Front Bumper, Grille, Lamps - Scratch & Dent - Large / (L) Mirror - Scratch - Small / (L) Rear Door, Molding - Scratch & Dent - Large / (L) Step, In-panel, Side Spoiler - Scratch - Small / (L) Front Fender, Molding - Scratch - Small / (L) Rear Fender, Molding - Scratch & Dent - Small / Rear Bumper, Lamps, Panels - Scratch & Dent - Large / (R) Rear Fender, Molding - Scratch - Small / (R) Front Fender, Molding - Scratch - Small / (R) Step, In-panel, Side Spoiler - Scratch - Medium / (R) Front Door, Molding - Scratch - Small / (R) Rear Door, Molding - Scratch - Small / Trunk Hood, Rear Gate - Dent - Small / Roof - Scratch - Minimal</p>
