## General Information

| Make | Toyota | Model | Vios |
| YOM | 2024 | Odo Meter Reading | 15,072 |

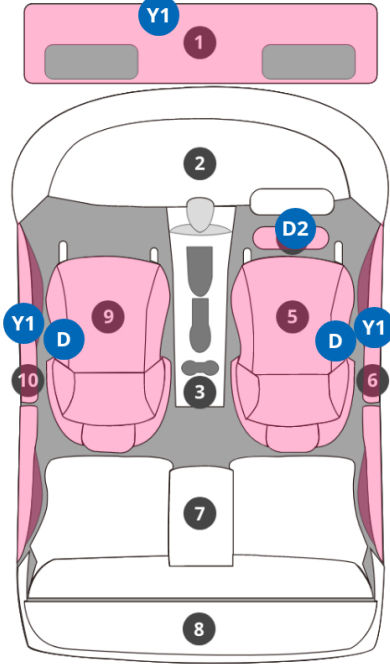
| Interior Evaluation : <b>B</b> | Exterior Evaluation : <b>E</b> |
|---|---|
| <p><b>Remarks</b><br/>(R) Front Seat - Worn - Yes / (L) Front Seat - Worn - Yes / (R) Front Trim - Grime - Minimal / (L) Front Trim - Grime - Minimal / (L) Front Floor Mat - Worked - Small / Ceiling - Grime - Minimal</p> | <p><b>Remarks</b><br/>(R) Mirror - Faded(Color, Gloss) - Yes / (R) Mirror - Scratch - Small / (R) Step, In-panel, Side Spoiler - Scratch - Small / (R) Front Fender, Molding - Scratch - Small / (R) Rear Door, Molding - Scratch - Large / (R) Front Door, Molding - Scratch - Large / (R) Rear Fender, Molding - Dent - Minimal / Trunk Hood, Rear Gate - Scratch &amp; Dent - Small / (L) Rear Fender, Molding - Scratch &amp; Dent - Minimal / (L) Rear Door, Molding - Scratch - Small / (L) Front Door, Molding - Scratch &amp; Dent - Medium / (L) Step, In-panel, Side Spoiler - Scratch - Minimal / (L) Mirror - Scratch - Minimal / (L) Front Fender, Molding - Scratch - Minimal / Member (Bolted) - Dent - Yes / Bonnet, Headlight - Scratch - Small / Front Bumper, Grille, Lamps - Scratch - Large / Roof - Repair mark - Yes / Roof - Scratch - Small</p> |

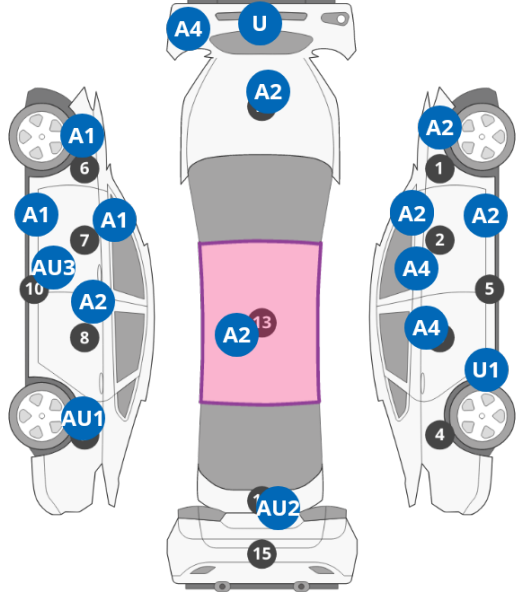
| Inspector Notes |
|---|
| with warranty booklet, with jack, no tools, with spare tire, with LTO plate, scratches on tail light, right side mirror repaired |
