## General Information

| Make | Suzuki | Model | Carry |
| YOM | 2024 | Odo Meter Reading | 8,752 |
| Registration No. | DBP2439 | Chassis No. | MHYDC61T4SJ210386 |

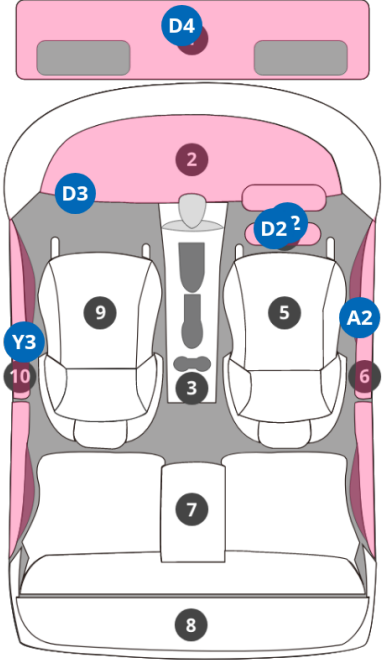
| Interior Evaluation : <b>C</b> | Exterior Evaluation : <b>E</b> |
|---|---|
| <b>Remarks</b><br>Dashboard - Loose, Deformed - Medium / Ceiling - Crinkle - Large / (R) Front Floor Mat - Worked - Small / (L) Front Floor Mat - Worked - Small / (L) Front Trim - Grime - Medium / (R) Front Trim - Cut, Crack - Small | <b>Remarks</b><br>(R) Side Gate - Repair mark - Yes / (L) Side Gate - Repair mark - Yes / (R) Front Fender, Molding - Scratch & Dent - Medium / (R) Front Door, Molding - Scratch - Medium / (R) Side Gate - Scratch - Small / Rear Gate - Scratch - Small / Cargo Bed Floor - Scratch - Medium / (L) Side Gate - Scratch - Small / (L) Front Door, Molding - Scratch - Medium / (L) Center Panel - Scratch - Minimal / Front Bumper, Grille, Lamps - Scratch - Small / Front Panel - Dent - Medium / Roof - Scratch & Dent - Large |
