## General Information

| Make | Toyota | Model | Vios |
| Registration No. | DBQ9106 | Chassis No. | PA1B18F37R4271508 |

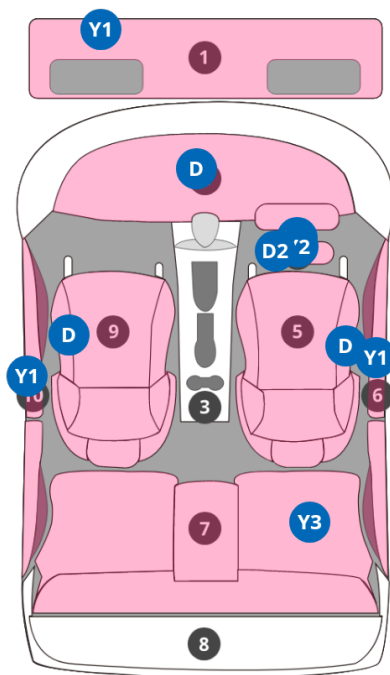
| Interior Evaluation : <span style="color: red;">C</span> | Exterior Evaluation : <span style="color: red;">C</span> |
|---|---|
| <b>Remarks</b><br>Rear Seat - Grime - Medium / (R) Front Seat - Worn - Yes / (L) Front Seat - Worn - Yes / (R) Front Trim - Grime - Minimal / (R) Front Floor Mat - Grime - Medium / Mat Other - Grime - Small / (L) Front Trim - Grime - Minimal / (L) Front Floor Mat - Worked - Small / Dashboard - Traces of Adhesive Tape - Yes / Ceiling - Grime - Minimal | <b>Remarks</b><br>(R) Front Fender, Molding - Scratch - Minimal / (R) Mirror - Scratch - Minimal / (R) Front Door, Molding - Scratch & Dent - Minimal / (R) Step, In-panel, Side Spoiler - Scratch & Dent - Medium / (R) Rear Door, Molding - Scratch - Minimal / (R) Rear Fender, Molding - Dent - Minimal / Rear Bumper, Lamps, Panels - Scratch & Dent - Small / Trunk Hood, Rear Gate - Scratch & Dent - Minimal / (L) Rear Fender, Molding - Scratch - Small / (L) Rear Door, Molding - Scratch - Small / (L) Mirror - Scratch - Minimal / (L) Front Door, Molding - Scratch - Minimal / (L) Front Fender, Molding - Scratch - Small / Front Bumper, Grille, Lamps - Scratch - Small / Bonnet, Headlight - Scratch - Minimal |

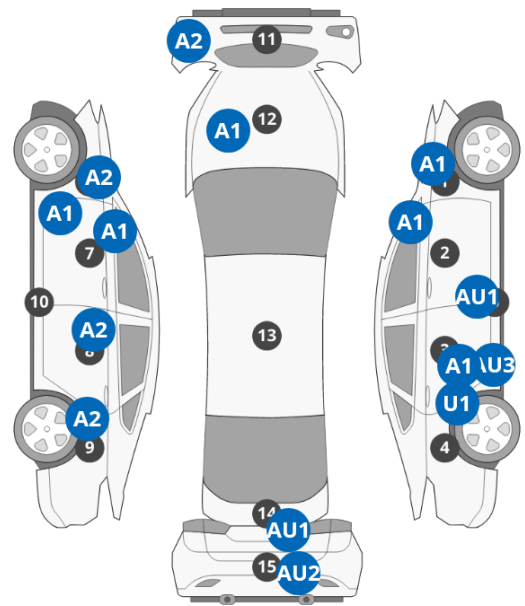
| Inspector Notes |
|---|
| with warranty booklet, with jack and tools, with spare tire, with LTO plate, scratches on tail light |
