## General Information

| Make | Toyota | Model | Wigo |

## Body / Panel Condition

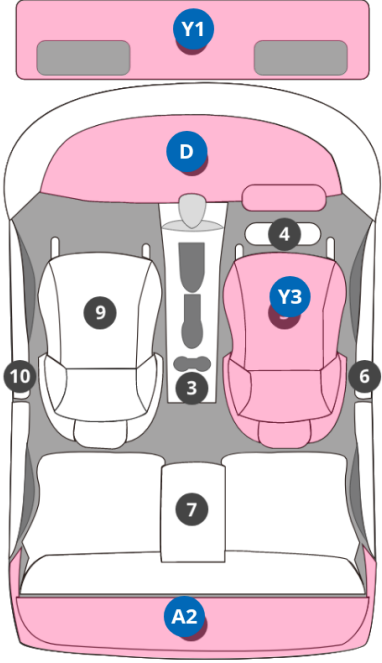
| <b>Remarks</b><br>Trunk Room - Worn, Scratch, Cut, Crack - Small /<br>Dashboard - Traces of Adhesive Tape - Yes / (R) Front<br>Seat - Grime - Medium / Ceiling - Grime - Minimal | <b>Remarks</b><br>(R) Front Door, Molding - Scratch - Minimal / Front<br>Bumper, Grille, Lamps - Scratch - Medium / Bonnet,<br>Headlight - Scratch - Small / (R) Rear Door, Molding -<br>Scratch - Minimal / (L) Front Fender, Molding - Scratch -<br>Minimal / (L) Front Door, Molding - Scratch - Minimal /<br>(L) Rear Door, Molding - Scratch - Small |
