## General Information

| Make | Toyota | Model | Vios |
| YOM | 2024 | Odo Meter Reading | 20,775 |

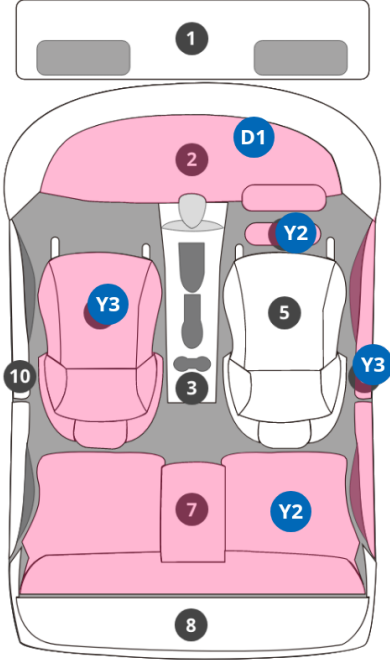
| <b>Remarks</b><br>Rear Seat - Grime - Small / (R) Front Trim - Grime - Medium / (L) Front Seat - Grime - Medium / Mat Other - Grime - Small / Dashboard - Loose, Deformed - Minimal | <b>Remarks</b><br>(R) Front Fender, Molding - Scratch - Medium / (R) Front Door, Molding - Scratch - Minimal / (R) Rear Door, Molding - Scratch - Minimal / (R) Rear Fender, Molding - Scratch - Small / Rear Bumper, Lamps, Panels - Scratch - Medium / Trunk Hood, Rear Gate - Scratch - Minimal / (L) Rear Fender, Molding - Scratch & Dent - Small / (L) Rear Door, Molding - Scratch & Dent - Medium / (L) Mirror - Scratch - Small / (L) Front Fender, Molding - Scratch - Small / Front Bumper, Grille, Lamps - Scratch - Minimal / Bonnet, Headlight - Scratch - Small / Roof - Scratch - Minimal |
