## General Information

| Make | Toyota | Model | Vios |
| Registration No. | NFR5849 | Chassis No. | PA1B18F3XR4255397 |

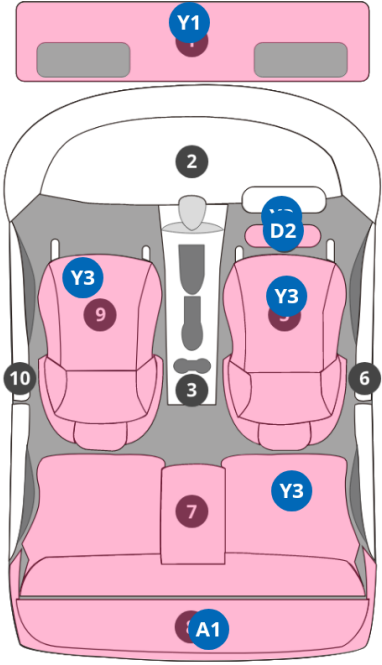
| Interior Evaluation : <span style="color: red;">C</span> | Exterior Evaluation : <span style="color: red;">C</span> |
| <p><b>Remarks</b><br/>Trunk Room - Worn, Scratch, Cut, Crack - Minimal / Rear Seat - Grime - Medium / Mat Other - Grime - Medium / (R) Front Seat - Grime - Medium / Ceiling - Grime - Minimal / (L) Front Seat - Grime - Medium / (L) Front Floor Mat - Worked - Small</p> | <p><b>Remarks</b><br/>Front Bumper, Grille, Lamps - Scratch - Large / (R) Front Fender, Molding - Scratch - Small / (R) Front Door, Molding - Scratch - Medium / (R) Rear Door, Molding - Scratch - Small / (R) Rear Fender, Molding - Scratch &amp; Dent - Medium / (L) Rear Fender, Molding - Scratch - Small / (L) Rear Door, Molding - Scratch - Small / (L) Front Door, Molding - Scratch - Small / (L) Front Fender, Molding - Scratch - Small / Roof - Scratch &amp; Dent - Small / Bonnet, Headlight - Scratch - Minimal / Rear Bumper, Lamps, Panels - Scratch - Minimal / Trunk Hood, Rear Gate - Scratch - Minimal</p> |
