## General Information

| Make | Toyota | Model | Vios |
| YOM | 2024 | Odo Meter Reading | 30,597 |
| Registration No. | NFR1388 | Chassis No. | PA1B18F30R4247647 |

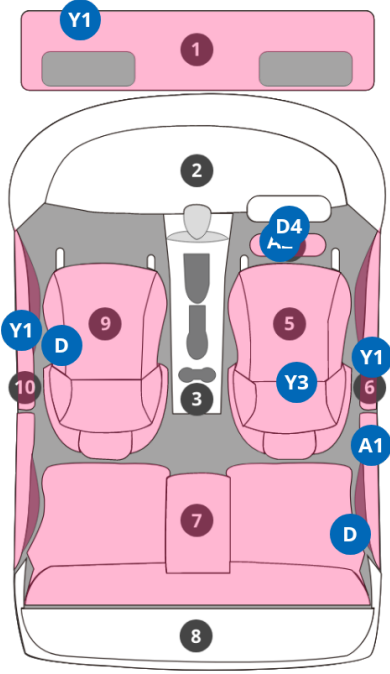
| Interior Evaluation : <span style="color: red;">C</span> | Exterior Evaluation : <span style="color: red;">C</span> |
|---|---|
| <p><b>Remarks</b></p> <p>(R) Front Seat - Grime - Medium / (L) Front Seat - Worn - Yes / Rear Seat - Worn - Yes / (R) Rear Trim - Cut, Crack - Minimal / (R) Front Trim - Grime - Minimal / (L) Front Floor Mat - Cut, Crack - Small / (L) Front Floor Mat - Worked - Large / (L) Front Trim - Grime - Minimal / Ceiling - Grime - Minimal</p> | <p><b>Remarks</b></p> <p>(R) Front Fender, Molding - Scratch &amp; Dent - Small / (R) Front Door, Molding - Scratch - Small / (R) Step, In-panel, Side Spoiler - Scratch &amp; Dent - Small / (R) Rear Fender, Molding - Scratch &amp; Dent - Minimal / Rear Bumper, Lamps, Panels - Scratch - Minimal / Trunk Hood, Rear Gate - Scratch - Small / (L) Rear Fender, Molding - Scratch &amp; Dent - Minimal / (L) Rear Door, Molding - Scratch - Small / (L) Front Door, Molding - Scratch - Small / (L) Step, In-panel, Side Spoiler - Scratch &amp; Dent - Medium / (L) Mirror - Scratch - Small / (L) Front Fender, Molding - Scratch - Minimal / Front Bumper, Grille, Lamps - Repair mark - Yes / Front Bumper, Grille, Lamps - Scratch - Medium / Bonnet, Headlight - Scratch - Minimal / Roof - Scratch - Minimal / (R) Rear Door, Molding - Scratch &amp; Dent - Small</p> |

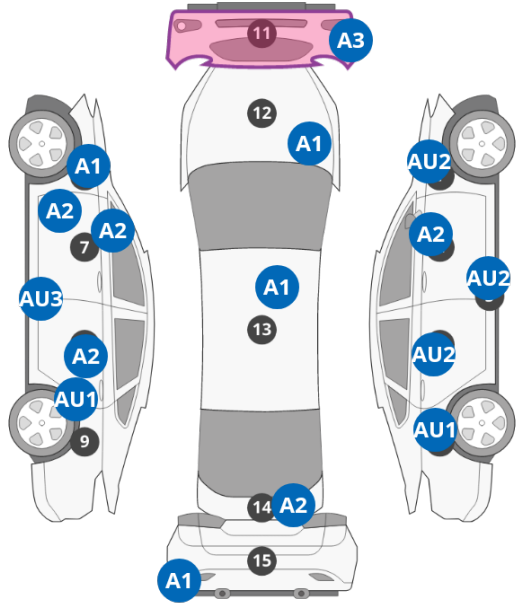
| Inspector Notes |
|---|
| with warranty booklet, with jack and tools, with spare tire, with LTO plate, scratches on tail light |
