## General Information

| Make | Toyota | Model | Vios |
| Registration No. | NKA8363 | Chassis No. | PA1B18F3XR4247302 |

## Body / Panel Condition

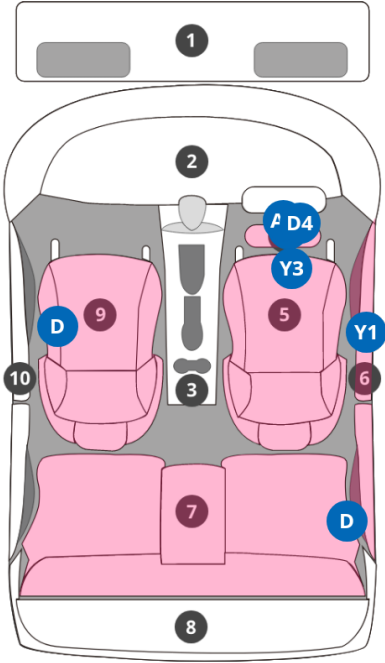
| Interior Evaluation : <span style="color: red;">C</span> | Exterior Evaluation : <span style="color: red;">C</span> |
| <b>Remarks</b><br>(R) Front Seat - Grime - Medium / (L) Front Seat - Worn - Yes / Rear Seat - Worn - Yes / (R) Front Trim - Grime - Minimal / (R) Front Floor Mat - Grime - Small / (L) Front Floor Mat - Cut, Crack - Minimal / (L) Front Floor Mat - Worked - Large | <b>Remarks</b><br>(R) Front Fender, Molding - Scratch - Small / (R) Mirror - Scratch - Minimal / (R) Rear Door, Molding - Scratch - Large / (R) Front Door, Molding - Scratch - Small / (R) Rear Fender, Molding - Scratch - Medium / Rear Bumper, Lamps, Panels - Scratch - Small / Trunk Hood, Rear Gate - Scratch - Minimal / (L) Rear Fender, Molding - Scratch - Minimal / (L) Rear Door, Molding - Scratch - Minimal / (L) Front Door, Molding - Scratch - Small / (L) Mirror - Scratch - Minimal / (L) Front Fender, Molding - Scratch - Minimal / Front Bumper, Grille, Lamps - Scratch & Dent - Minimal / Bonnet, Headlight - Scratch - Minimal / Roof - Scratch - Minimal |

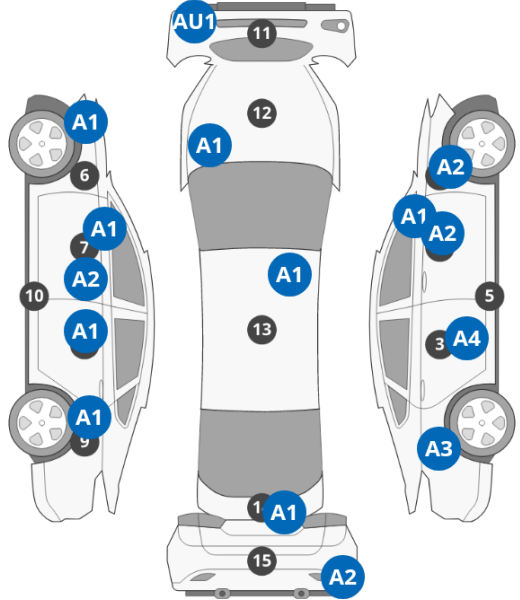
| Inspector Notes |
|---|
| no warranty booklet, no jack and tools, with spare tire, with LTO plate, scratches on headlight, trunk floormat missing |
