## General Information

| Make | Toyota | Model | Vios |
| YOM | 2025 | Odo Meter Reading | 13,314 |

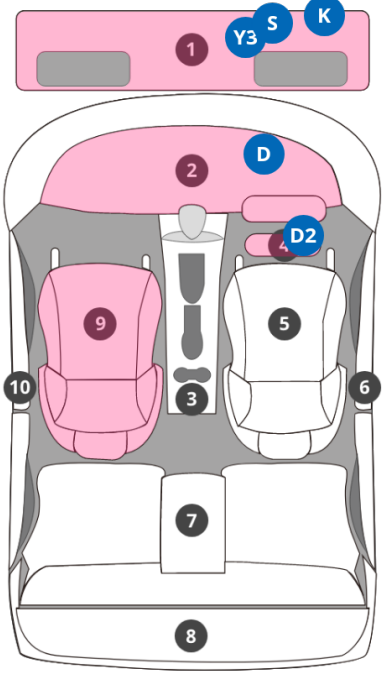
| Interior Evaluation : <b>B</b> | Exterior Evaluation : <b>C</b> |
| <b>Remarks</b><br>(L) Front Floor Mat - Worked - Small / Ceiling - Grime - Medium / Overall Interior - Smell - Yes / Overall Interior - Animal Hair - Yes / Dashboard - Traces of Adhesive Tape - Yes / (L) Front Seat Knobs - Stuck - Yes | <b>Remarks</b><br>Member (Bolted) - Dent - Yes / (L) Rear Fender, Molding - Scratch & Dent - Medium / (L) Rear Door, Molding - Scratch & Dent - Medium / (L) Front Door, Molding - Scratch - Small / (L) Front Fender, Molding - Scratch - Minimal / Front Bumper, Grille, Lamps - Scratch & Dent - Small / (R) Front Door, Molding - Scratch - Minimal / (R) Rear Door, Molding - Scratch - Small / (R) Front Fender, Molding - Scratch - Minimal / Bonnet, Headlight - Scratch - Minimal / (R) Rear Fender, Molding - Scratch & Dent - Small / Rear Bumper, Lamps, Panels - Scratch & Dent - Medium / Trunk Hood, Rear Gate - Scratch - Small / Roof - Scratch & Dent - Medium |

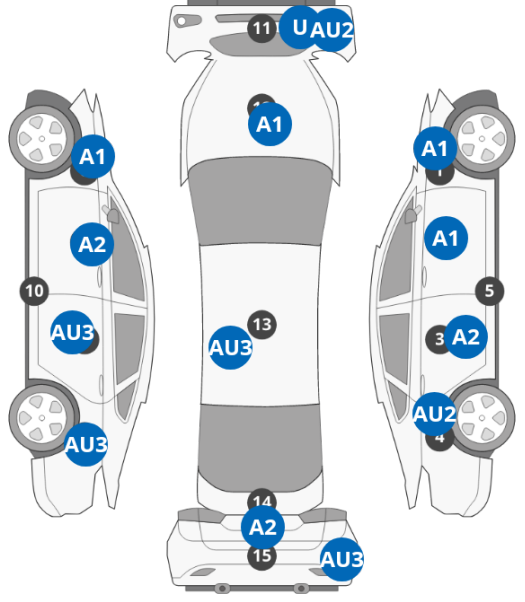
With LTO plate and Sparetire. no warranty booklet, Jack and Tools. scratch headlight and tail light. adhesive marks on trunk and back glass.
