## General Information

| Make | Toyota | Model | Vios |
| YOM | 2024 | Odo Meter Reading | 9,701 |
| Registration No. | VAB9597 | Chassis No. | PA1B18F3XR4247154 |

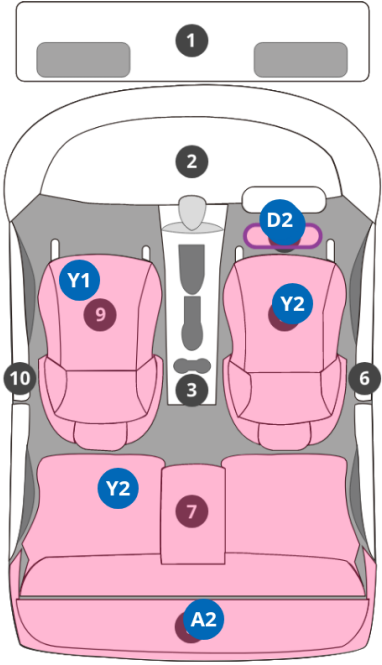
| Interior Evaluation : <b>B</b> | Exterior Evaluation : <b>D</b> |
| <b>Remarks</b><br>Trunk Room - Worn, Scratch, Cut, Crack - Small / Mat<br>Other - Missing - Yes / Rear Seat - Grime - Small / (L)<br>Front Floor Mat - Worked - Small / (R) Front Seat -<br>Grime - Small / (L) Front Seat - Grime - Minimal | <b>Remarks</b><br>(R) Front Wheel, Cover - Scratch, Corrosion - Small / (R) Front Fender, Molding - Scratch - Small / (R) Front Door, Molding - Scratch - Medium / (R) Mirror - Scratch - Small / (R) Rear Door, Molding - Scratch - Medium / (R) Rear Fender, Molding - Scratch - Small / Rear Bumper, Lamps, Panels - Scratch - Medium / Trunk Hood, Rear Gate - Scratch - Small / (L) Rear Fender, Molding - Scratch - Small / (L) Rear Door, Molding - Scratch - Minimal / (L) Front Door, Molding - Scratch - Minimal / (L) Mirror - Scratch - Minimal / (R) Rear Wheel, Cover - Scratch, Corrosion - Small / Front Bumper, Grille, Lamps - Scratch & Dent - Large / Bonnet, Headlight - Scratch - Small / Roof - Scratch - Minimal / (L) Front Fender, Molding - Scratch - Minimal |
