General Information

Make	Hino	Model	315
YOM	2024	Odo Meter Reading	6,450
Registration No.	NKG9462	Chassis No.	JHHAGP6ERK004829
CC	2.8	Transmission	M/T
Fuel Type	Diesel	Type of Body	MPV
Colour	White

Body / Panel Condition

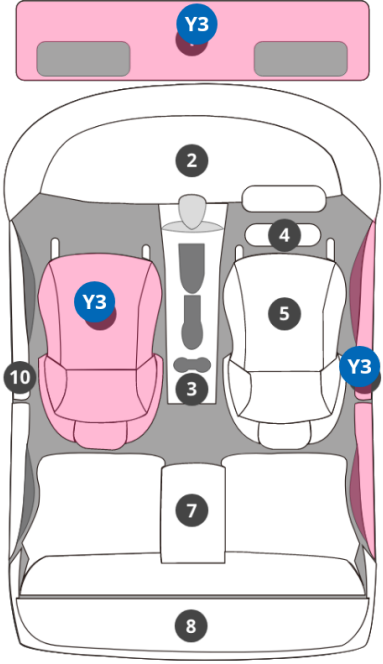
Interior Evaluation : B	Exterior Evaluation : C

<p>a : Cut, Fray d : Loose, Deformed k : Animal Hair s : Smell t : Cigarette Burns x : Defective y : Stain</p>

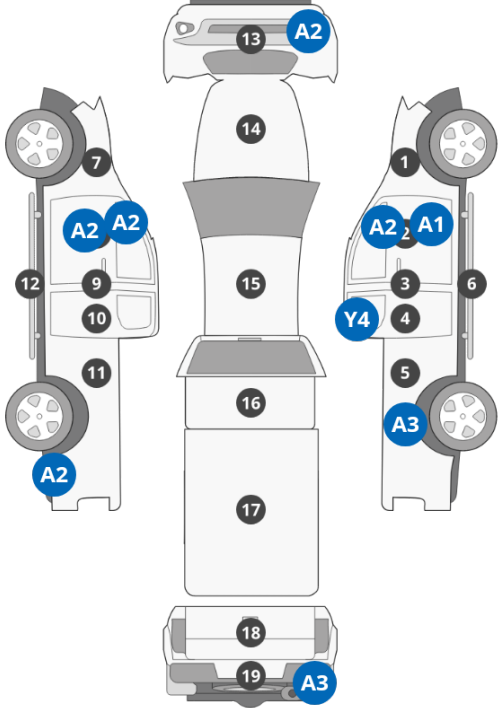
<p>A : Scratch AU : Scratch & Dent B : Modified C : Corrosion G : Stone chip P : Faded S : Rust SC : Rust & Corrosion U : Dent X : Defective Y : Crack, Gap</p>
<p>Remarks Ceiling - Grime - Medium / (R) Front Trim - Grime - Medium / (L) Front Seat - Grime - Medium</p>	<p>Remarks (R) Rear Corner Panel - Repair Traces - Yes / (L) Front Door, Molding - Scratch - Small / (L) Mirror - Scratch - Small / (R) Front Door, Molding - Scratch - Minimal / (R) Side Gate - Scratch - Medium / (R) Side Window - Damaged - Large / Rear Bumper, Lamps, Panels - Scratch - Medium / (L) Side Gate - Scratch - Small / Front Bumper, Grille, Lamps - Scratch - Small / (R) Mirror - Scratch - Small</p>
Frame Evaluation : A	Functional Evaluation : A
<p>Remarks Defects not found</p>	<p>Remarks Reverse Camera - N/A - Yes</p>
