## General Information

<b>Make</b>	Toyota	<b>Model</b>	Vios
<b>YOM</b>	2022	<b>Odo Meter Reading</b>	32,432
<b>Registration No.</b>	NFP5892	<b>Chassis No.</b>	PA1B18F31N4191793
<b>CC</b>	1.3	<b>Transmission</b>	CVT
<b>Fuel Type</b>	Gas	<b>Type of Body</b>	Sedan
<b>Colour</b>	Blackish Red Mica

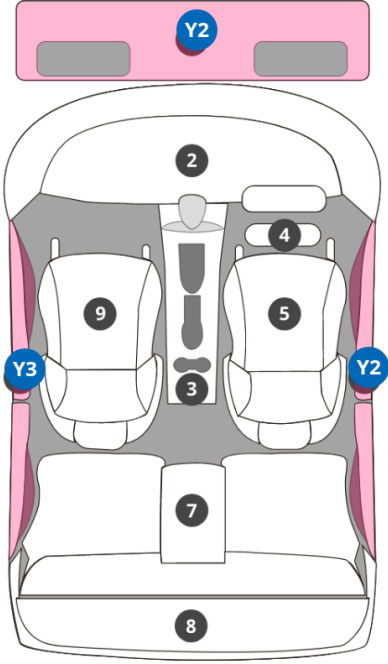
<b>Interior Evaluation :</b> <span style="float: right;"><b>B</b></span>	<b>Exterior Evaluation :</b> <span style="float: right;"><b>E</b></span>

<p><b>a</b> : Cut, Fray <b>d</b> : Loose, Deformed <b>k</b> : Animal Hair <b>s</b> : Smell <b>t</b> : Cigarette Burns <b>x</b> : Defective <b>y</b> : Stain</p>

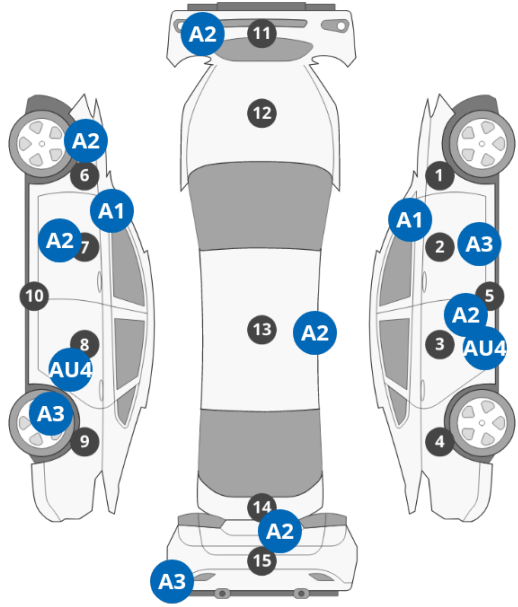
<p><b>A</b> : Scratch <b>AU</b> : Scratch &amp; Dent <b>B</b> : Modified <b>C</b> : Corrosion <b>G</b> : Stone chip <b>P</b> : Faded <b>S</b> : Rust <b>SC</b> : Rust &amp; Corrosion <b>U</b> : Dent <b>X</b> : Defective <b>Y</b> : Crack, Gap</p>
<p><b>Remarks</b> (R) Front Trim - Grime - Small / Ceiling - Grime - Small / (L) Front Trim - Grime - Medium</p>	<p><b>Remarks</b> (R) Step, In-panel, Side Spoiler - Scratch &amp; Dent - Large / (R) Front Door, Molding - Scratch - Medium / (R) Rear Door, Molding - Scratch - Small / Rear Bumper, Lamps, Panels - Scratch - Medium / Trunk Hood, Rear Gate - Scratch - Small / (L) Rear Fender, Molding - Scratch - Medium / (L) Front Door, Molding - Scratch - Small / (L) Mirror - Scratch - Minimal / (L) Front Fender, Molding - Scratch - Small / Front Bumper, Grille, Lamps - Scratch - Small / (R) Mirror - Scratch - Minimal / Roof - Scratch - Small / (L) Rear Door, Molding - Scratch &amp; Dent - Large</p>
