General Information

Make	Toyota	Model	Innova
YOM	2024	Odo Meter Reading	21,217
Registration No.	CCA6523	Chassis No.	PA2JA8EM9R0139729
CC	2.8	Transmission	A/T
Fuel Type	Diesel	Type of Body	Wagon
Colour	Blackish Red Mica

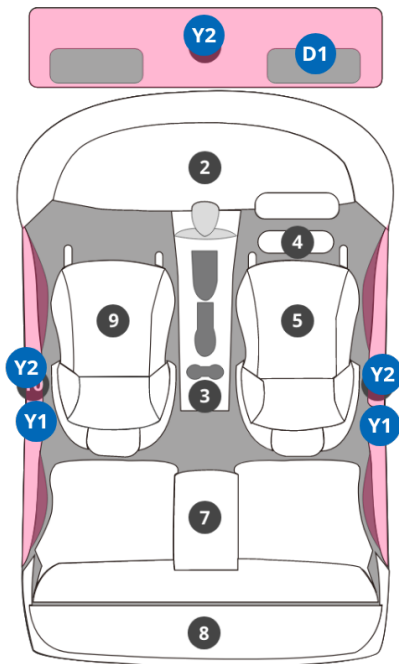
Interior Evaluation : A	Exterior Evaluation : D

<p>a : Cut, Fray d : Loose, Deformed k : Animal Hair s : Smell t : Cigarette Burns x : Defective y : Stain</p>

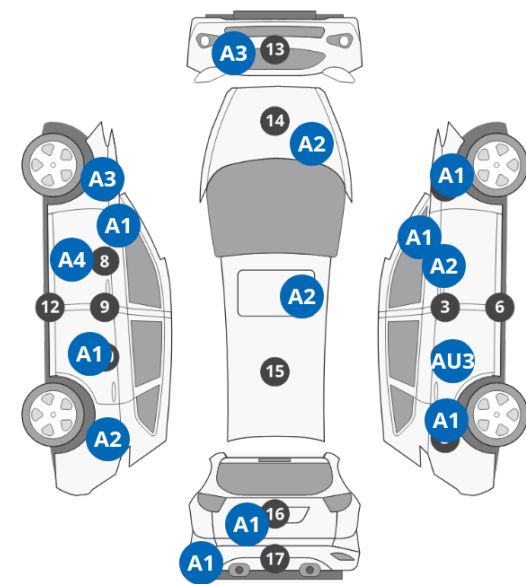
<p>A : Scratch AU : Scratch & Dent B : Modified C : Corrosion G : Stone chip P : Faded S : Rust SC : Rust & Corrosion U : Dent X : Defective Y : Crack, Gap</p>
<p>Remarks Ceiling - Grime - Small / (R) Front Trim - Grime - Small / (R) Rear Trim - Grime - Minimal / (L) Rear Trim - Grime - Minimal / (L) Front Trim - Grime - Small / Sunvisor, Sunglass Holder - Crinkle - Minimal</p>	<p>Remarks Trunk Hood, Rear Gate - Repair Traces - Yes / (R) Front Fender, Molding - Scratch - Minimal / (R) Mirror - Scratch - Minimal / (R) Front Door, Molding - Scratch - Small / (R) Rear Door, Molding - Scratch & Dent - Medium / (R) Rear Fender, Molding - Scratch - Minimal / Trunk Hood, Rear Gate - Scratch - Minimal / Rear Bumper, Lamps, Panels - Scratch - Minimal / (L) Rear Fender, Molding - Scratch - Small / (L) Rear Door, Molding - Scratch - Minimal / (L) Front Door, Molding - Scratch - Large / (L) Mirror - Scratch - Minimal / (L) Front Fender, Molding - Scratch - Medium / Front Bumper, Grille, Lamps - Scratch - Medium / Bonnet, Headlight - Scratch - Small / Roof - Scratch - Small</p>
