## General Information

<b>Make</b>	Toyota	<b>Model</b>	Vios
<b>YOM</b>	2025	<b>Odo Meter Reading</b>	11,246
<b>Registration No.</b>	CCG4970	<b>Chassis No.</b>	PA1B18F32R4270119
<b>CC</b>	1.3	<b>Transmission</b>	CVT
<b>Fuel Type</b>	Gas	<b>Type of Body</b>	Sedan
<b>Colour</b>	Black

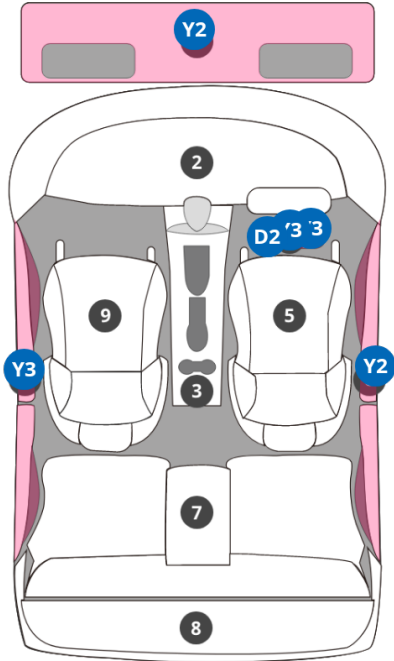
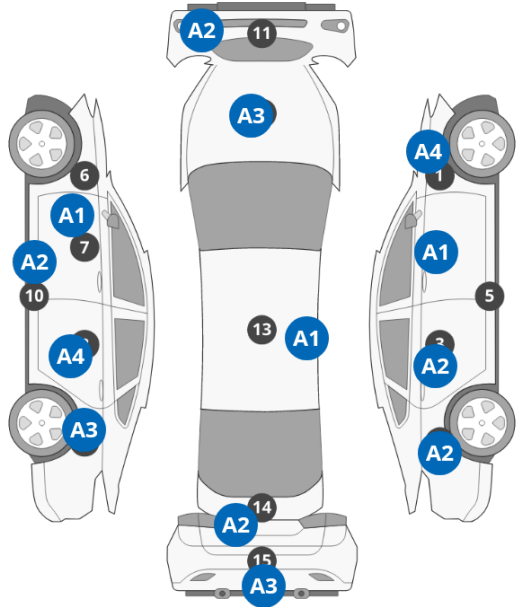
<b>Interior Evaluation :</b>	<b>B</b>	<b>Exterior Evaluation :</b>	<b>D</b>

<p><b>a</b> : Cut, Fray <b>d</b> : Loose, Deformed <b>k</b> : Animal Hair <b>s</b> : Smell <b>t</b> : Cigarette Burns <b>x</b> : Defective <b>y</b> : Stain</p>		<p><b>A</b> : Scratch <b>AU</b> : Scratch &amp; Dent <b>B</b> : Modified <b>C</b> : Corrosion <b>G</b> : Stone chip <b>P</b> : Faded <b>S</b> : Rust <b>SC</b> : Rust &amp; Corrosion <b>U</b> : Dent <b>X</b> : Defective <b>Y</b> : Crack, Gap</p>	
<p><b>Remarks</b> Ceiling - Grime - Small / (R) Front Trim - Grime - Small / (R) Front Floor Mat - Grime - Medium / Mat Other - Grime - Medium / (L) Front Trim - Grime - Medium / (L) Front Floor Mat - Worked - Small</p>		<p><b>Remarks</b> (R) Rear Fender, Molding - Scratch - Small / (R) Rear Door, Molding - Scratch - Small / (R) Front Door, Molding - Scratch - Minimal / Rear Bumper, Lamps, Panels - Scratch - Medium / Trunk Hood, Rear Gate - Scratch - Small / (L) Rear Fender, Molding - Scratch - Medium / (L) Rear Door, Molding - Scratch - Large / (L) Front Door, Molding - Scratch - Minimal / (L) Step, In-panel, Side Spoiler - Scratch - Small / Bonnet, Headlight - Scratch - Medium / Front Bumper, Grille, Lamps - Scratch - Small / (R) Front Fender, Molding - Scratch - Large / Roof - Scratch - Minimal</p>
