General Information

Make	Toyota	Model	Hilux
YOM	2025	Odo Meter Reading	4,742
Registration No.	BAG8212	Chassis No.	MR0BA3CD2R6617319
CC	2.8	Transmission	A/T
Fuel Type	Diesel	Type of Body	Pickup
Colour	Black

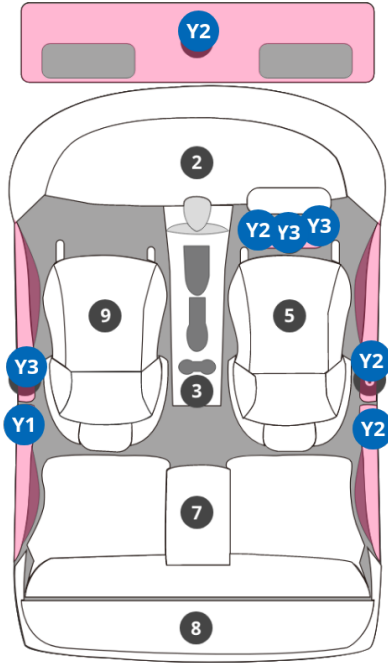
Interior Evaluation : C	Exterior Evaluation : A

<p>a : Cut, Fray d : Loose, Deformed k : Animal Hair s : Smell t : Cigarette Burns x : Defective y : Stain</p>

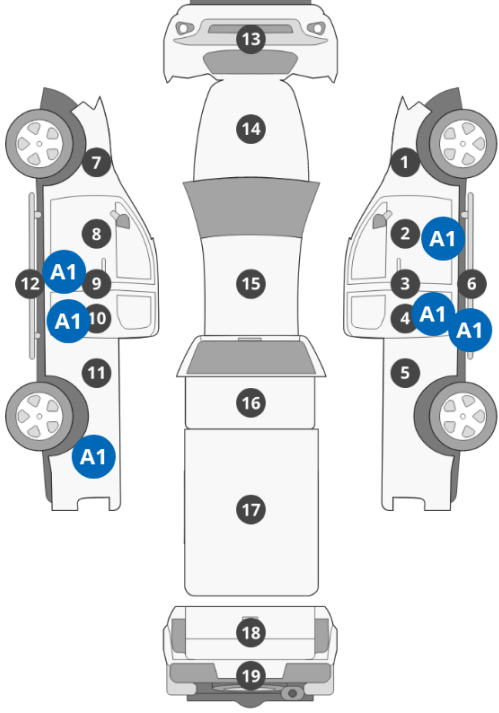
<p>A : Scratch AU : Scratch & Dent B : Modified C : Corrosion G : Stone chip P : Faded S : Rust SC : Rust & Corrosion U : Dent X : Defective Y : Crack, Gap</p>
<p>Remarks Ceiling - Grime - Small / (R) Front Trim - Grime - Small / (R) Front Floor Mat - Grime - Medium / Mat Other - Grime - Medium / (R) Rear Trim - Grime - Small / (L) Rear Trim - Grime - Minimal / (L) Front Trim - Grime - Medium / (L) Front Floor Mat - Grime - Small</p>	<p>Remarks (L) Side Gate - Scratch - Minimal / (L) Rear Door, Molding - Scratch - Minimal / (L) Front Door, Molding - Scratch - Minimal / (R) Front Door, Molding - Scratch - Minimal / (R) Rear Door, Molding - Scratch - Minimal / (R) Step, In-panel, Side Spoiler - Scratch - Minimal</p>
Frame Evaluation : A	Functional Evaluation : A
