General Information

Make	Toyota	Model	Vios
YOM	2025	Odo Meter Reading	23,769
Registration No.	CCG3870	Chassis No.	PA1B18F39R4267069
CC	1.3	Transmission	CVT
Fuel Type	Gas	Type of Body	Sedan
Colour	Blue

Body / Panel Condition

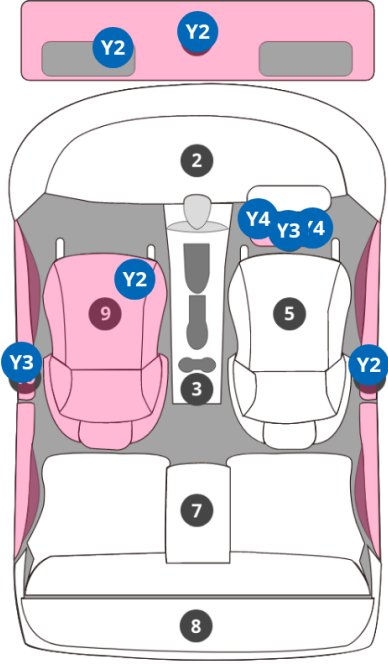
Interior Evaluation : C	Exterior Evaluation : B

<p>a : Cut, Fray d : Loose, Deformed k : Animal Hair s : Smell t : Cigarette Burns x : Defective y : Stain</p>

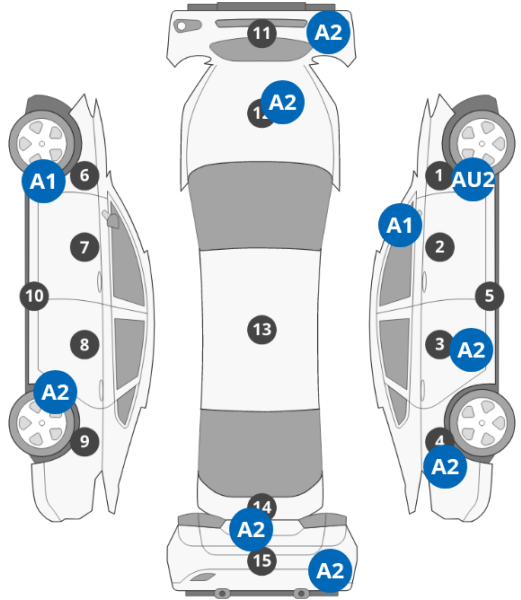
<p>A : Scratch AU : Scratch & Dent B : Modified C : Corrosion G : Stone chip P : Faded S : Rust SC : Rust & Corrosion U : Dent X : Defective Y : Crack, Gap</p>
<p>Remarks Ceiling - Grime - Small / (R) Front Trim - Grime - Small / (R) Front Floor Mat - Grime - Large / Mat Other - Grime - Medium / (L) Front Trim - Grime - Medium / (L) Front Floor Mat - Grime - Large / (L) Front Seat - Grime - Small / Sunvisor, Sunglass Holder - Grime - Small</p>	<p>Remarks (L) Rear Fender - Repair Traces - Yes / Trunk Hood, Rear Gate - Scratch - Small / (R) Front Fender, Molding - Scratch & Dent - Small / (R) Mirror - Scratch - Minimal / (R) Rear Door, Molding - Scratch - Small / (R) Rear Fender, Molding - Scratch - Small / (L) Rear Fender, Molding - Scratch - Small / Rear Bumper, Lamps, Panels - Scratch - Small / (L) Front Fender, Molding - Scratch - Minimal / Bonnet, Headlight - Scratch - Small / Front Bumper, Grille, Lamps - Scratch - Small</p>
