General Information

Make	Toyota	Model	Vios
YOM	2022	Odo Meter Reading	44,994
Registration No.	NFD1897	Chassis No.	PA18F38M4167389
CC	1.3	Transmission	M/T
Fuel Type	Gas	Type of Body	Sedan
Colour	Red Mica Metallic

Body / Panel Condition

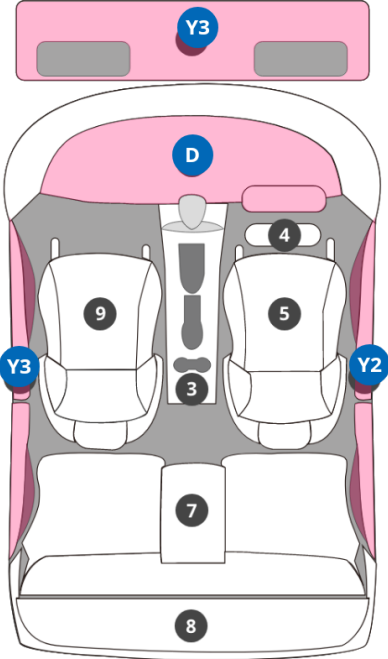
Interior Evaluation : B	Exterior Evaluation : E

<p>a : Cut, Fray d : Loose, Deformed k : Animal Hair s : Smell t : Cigarette Burns x : Defective y : Stain</p>

<p>Inspector Notes</p>
<p>Rusted bolts at seat railings. Left side mirror loose. With dashcam. Without warranty booklet. With Spare tire,jack,tools,and seat cover. 2 keys. With LTO plate.</p>

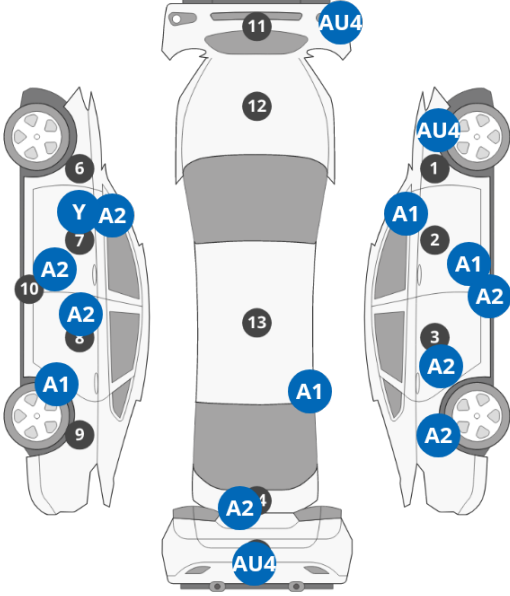
<p>A : Scratch AU : Scratch & Dent B : Modified C : Corrosion G : Stone chip P : Faded S : Rust SC : Rust & Corrosion U : Dent X : Defective Y : Crack, Gap</p>
<p>Remarks Ceiling - Grime - Medium / (R) Front Trim - Grime - Small / Dashboard - Traces of Adhesive Tape - Yes / (L) Front Trim - Grime - Medium</p>	<p>Remarks Front Bumper, Grille, Lamps - Scratch & Dent - Large / (R) Front Fender, Molding - Scratch & Dent - Large / (R) Mirror - Scratch - Minimal / (R) Front Door, Molding - Scratch - Minimal / (R) Rear Door, Molding - Scratch - Small / (R) Rear Fender, Molding - Scratch - Small / (R) Step, In-panel, Side Spoiler - Scratch - Small / Rear Bumper, Lamps, Panels - Scratch & Dent - Large / Trunk Hood, Rear Gate - Scratch - Small / (L) Rear Fender, Molding - Scratch - Minimal / (L) Rear Door, Molding - Scratch - Small / (L) Front Door, Molding - Scratch - Small / (L) Mirror - Scratch - Small / (L) Mirror - Crack - Damaged / Roof - Scratch - Minimal</p>
