## General Information

| Make | Toyota | Model | Vios |

## Body / Panel Condition

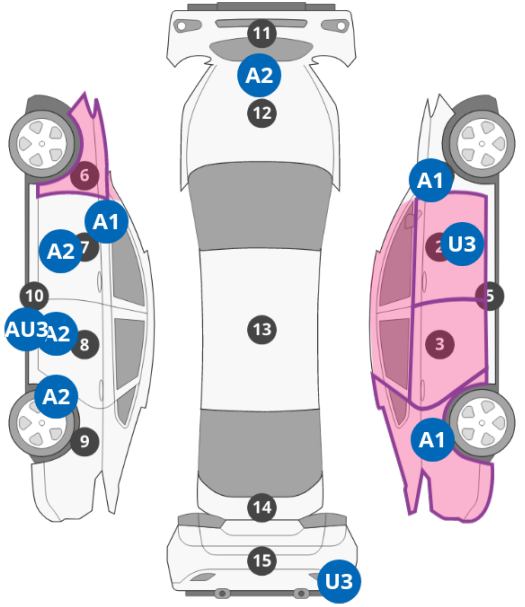
| Interior Evaluation : <b>A</b> | Exterior Evaluation : <b>C</b> |
|---|---|
| <b>Remarks</b><br>Defects not found | <b>Remarks</b><br>(R) Step - Repair Traces - Yes / (L) Front Fender - Repair Traces - Yes / Bonnet, Headlight - Scratch - Small / (L) Mirror - Scratch - Minimal / (L) Front Door, Molding - Scratch - Small / (L) Rear Door, Molding - Scratch - Small / (L) Rear Fender, Molding - Scratch - Small / Rear Bumper, Lamps, Panels - Dent - Medium / (R) Rear Fender, Molding - Scratch - Minimal / (R) Front Door, Molding - Dent - Medium / (R) Front Fender, Molding - Scratch - Minimal / (R) Front Door, Molding - Repair mark - Yes / (R) Rear Door, Molding - Repair mark - Yes / (R) Rear Fender, Molding - Repair mark - Yes / (L) Front Fender, Molding - Repair mark - Yes / (L) Step, In-panel, Side Spoiler - Scratch & Dent - Medium |

| Inspector Notes |
|---|
| swirlmarks and hairline scratches around the exterior. With warranty booklet and user manual. |
