General Information

Make	Toyota	Model	Vios
YOM	2025	Odo Meter Reading	22,150
Registration No.	NHS5917	Chassis No.	P1B18F30R4263976
CC	1.3	Transmission	CVT
Fuel Type	Gas	Type of Body	Sedan
Colour	Blackish Red Mica

Body / Panel Condition

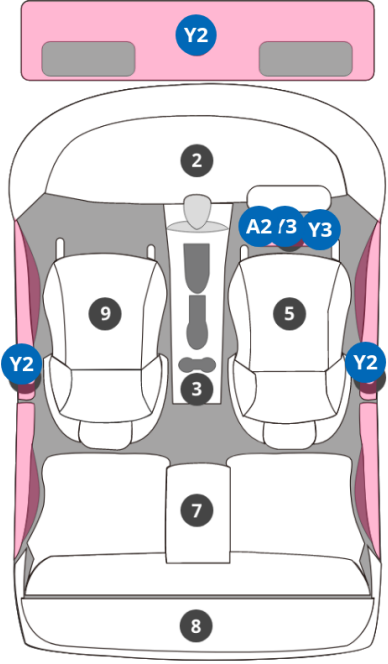
Interior Evaluation : B	Exterior Evaluation : C

<p>a : Cut, Fray d : Loose, Deformed k : Animal Hair s : Smell t : Cigarette Burns x : Defective y : Stain</p>

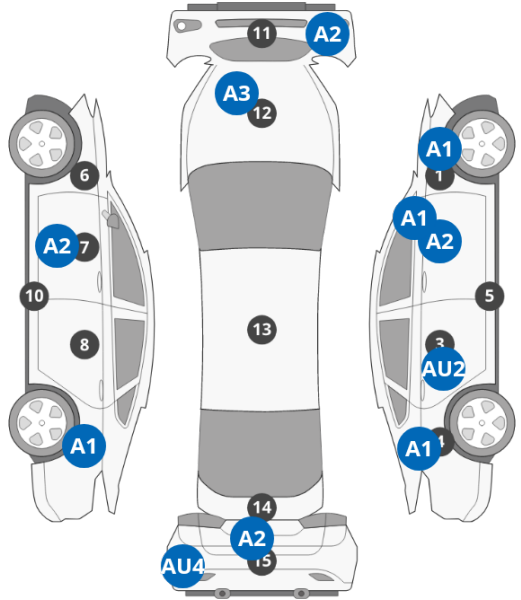
<p>A : Scratch AU : Scratch & Dent B : Modified C : Corrosion G : Stone chip P : Faded S : Rust SC : Rust & Corrosion U : Dent X : Defective Y : Crack, Gap</p>
<p>Remarks Ceiling - Grime - Small / (R) Front Trim - Grime - Small / (R) Front Floor Mat - Grime - Medium / Mat Other - Grime - Medium / (L) Front Trim - Grime - Small / (L) Front Floor Mat - Cut, Crack - Small</p>	<p>Remarks (L) Front Door, Molding - Scratch - Small / (L) Rear Fender, Molding - Scratch - Minimal / Rear Bumper, Lamps, Panels - Scratch & Dent - Large / Trunk Hood, Rear Gate - Scratch - Small / (R) Rear Fender, Molding - Scratch - Minimal / (R) Rear Door, Molding - Scratch & Dent - Small / (R) Front Door, Molding - Scratch - Small / (R) Mirror - Scratch - Minimal / (R) Front Fender, Molding - Scratch - Minimal / Bonnet, Headlight - Scratch - Medium / Front Bumper, Grille, Lamps - Scratch - Small</p>
