## General Information

<b>Make</b>	Toyota	<b>Model</b>	Innova
<b>YOM</b>	2025	<b>Odo Meter Reading</b>	7,484
<b>Registration No.</b>	CCG4122	<b>Chassis No.</b>	PA2JA8EM0R0146648
<b>CC</b>	2.8	<b>Transmission</b>	A/T
<b>Fuel Type</b>	Diesel	<b>Type of Body</b>	Wagon
<b>Colour</b>	Black

## Body / Panel Condition

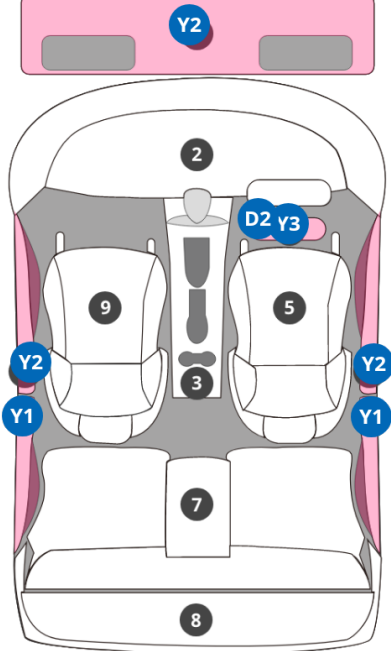
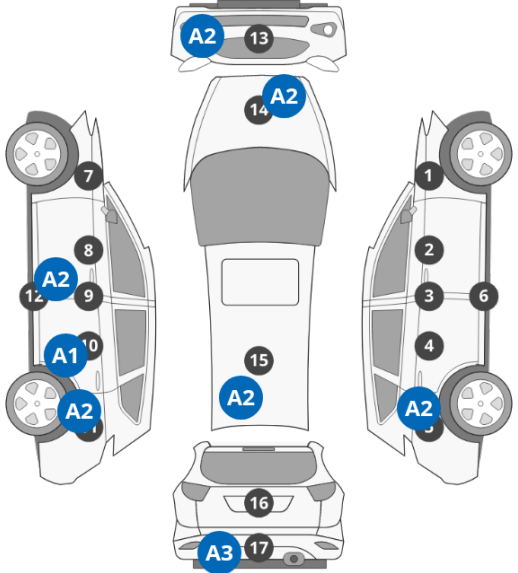
<b>Interior Evaluation :</b>	<b>B</b>	<b>Exterior Evaluation :</b>	<b>B</b>

<p><b>a</b> : Cut, Fray <b>d</b> : Loose, Deformed <b>k</b> : Animal Hair <b>s</b> : Smell <b>t</b> : Cigarette Burns <b>x</b> : Defective <b>y</b> : Stain</p>		<p><b>A</b> : Scratch <b>AU</b> : Scratch &amp; Dent <b>B</b> : Modified <b>C</b> : Corrosion <b>G</b> : Stone chip <b>P</b> : Faded <b>S</b> : Rust <b>SC</b> : Rust &amp; Corrosion <b>U</b> : Dent <b>X</b> : Defective <b>Y</b> : Crack, Gap</p>	
<p><b>Remarks</b> (R) Front Trim - Grime - Small / Mat Other - Grime - Medium / Ceiling - Grime - Small / (R) Rear Trim - Grime - Minimal / (L) Rear Trim - Grime - Minimal / (L) Front Trim - Grime - Small / (L) Front Floor Mat - Worked - Small</p>		<p><b>Remarks</b> (L) Rear Fender, Molding - Scratch - Small / (L) Rear Door, Molding - Scratch - Minimal / Bonnet, Headlight - Scratch - Small / (R) Rear Fender, Molding - Scratch - Small / Rear Bumper, Lamps, Panels - Scratch - Medium / Roof - Scratch - Small / (L) Front Door, Molding - Scratch - Small / Front Bumper, Grille, Lamps - Scratch - Small</p>
