General Information

Make	Toyota	Model	Vios
YOM	2025	Odo Meter Reading	5,640
Registration No.	CCG5138	Chassis No.	PA1B18F31R4273108
CC	1.3	Transmission	CVT
Fuel Type	Gas	Type of Body	Sedan
Colour	Blue

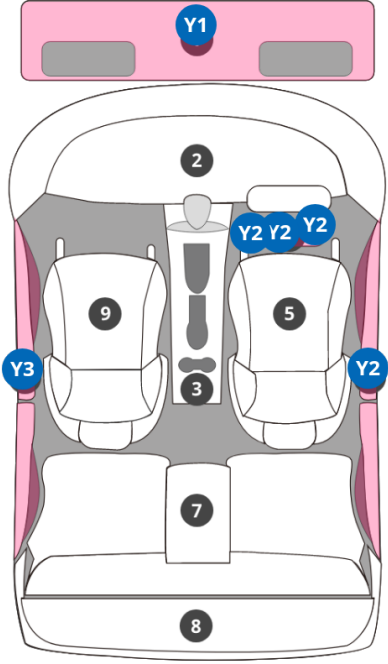
Interior Evaluation : B	Exterior Evaluation : B

<p>a : Cut, Fray d : Loose, Deformed k : Animal Hair s : Smell t : Cigarette Burns x : Defective y : Stain</p>

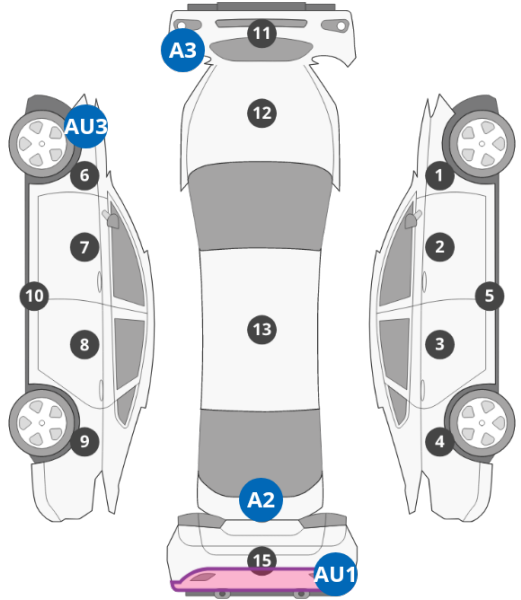
<p>A : Scratch AU : Scratch & Dent B : Modified C : Corrosion G : Stone chip P : Faded S : Rust SC : Rust & Corrosion U : Dent X : Defective Y : Crack, Gap</p>
<p>Remarks Ceiling - Grime - Minimal / (R) Front Trim - Grime - Small / (R) Front Floor Mat - Grime - Small / Mat Other - Grime - Small / (L) Front Trim - Grime - Medium / (L) Front Floor Mat - Grime - Small</p>	<p>Remarks (L) Front Fender, Molding - Scratch & Dent - Medium / Front Bumper, Grille, Lamps - Scratch - Medium / Rear Bumper, Lamps, Panels - Repair mark - Yes / Trunk Hood, Rear Gate - Scratch - Small / Rear Bumper, Lamps, Panels - Scratch & Dent - Minimal</p>
Frame Evaluation : A	Functional Evaluation : A
<p>Remarks Defects not found</p>	<p>Remarks Defects not found</p>
