General Information

Make	Toyota	Model	Vios
YOM	2023	Odo Meter Reading	2,802
Registration No.	BAF6054	Chassis No.	PA1B18F3P4214091
CC	1.3	Transmission	CVT
Fuel Type	Gas	Type of Body	Sedan
Colour	Black

Body / Panel Condition

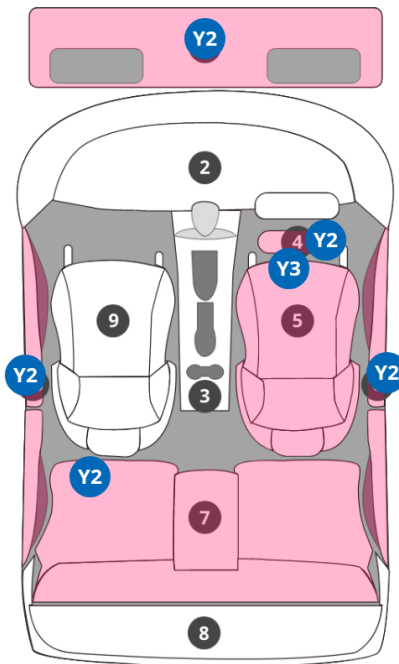
Interior Evaluation : B	Exterior Evaluation : D

<p>a : Cut, Fray d : Loose, Deformed k : Animal Hair s : Smell t : Cigarette Burns x : Defective y : Stain</p>

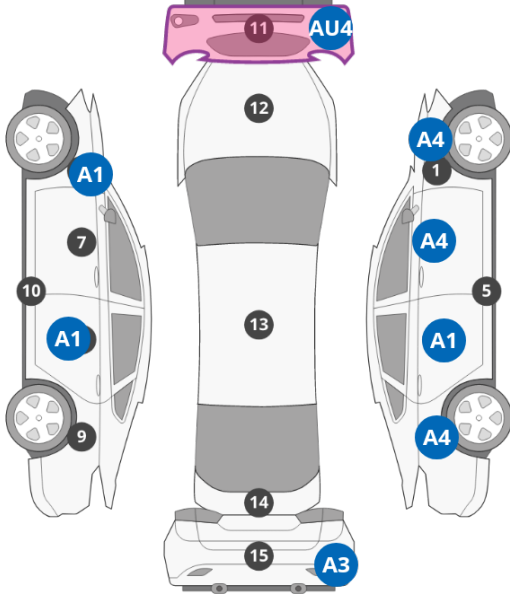
<p>A : Scratch AU : Scratch & Dent B : Modified C : Corrosion G : Stone chip P : Faded S : Rust SC : Rust & Corrosion U : Dent X : Defective Y : Crack, Gap</p>
<p>Remarks Ceiling - Grime - Small / (R) Front Trim - Grime - Small / (R) Front Seat - Grime - Medium / (R) Front Floor Mat - Grime - Small / Rear Seat - Grime - Small / (L) Front Trim - Grime - Small</p>	<p>Remarks (L) Front Fender, Molding - Scratch - Minimal / (L) Rear Door, Molding - Scratch - Minimal / Front Bumper, Grille, Lamps - Repair mark - Yes / Front Bumper, Grille, Lamps - Scratch & Dent - Large / (R) Front Fender, Molding - Scratch - Large / (R) Front Door, Molding - Scratch - Large / (R) Rear Door, Molding - Scratch - Minimal / (R) Rear Fender, Molding - Scratch - Large / Rear Bumper, Lamps, Panels - Scratch - Medium</p>
