General Information

Make	Toyota	Model	Vios
YOM	2021	Odo Meter Reading	58,079
Registration No.	NEV7317	Chassis No.	PA1B18F37M4156606
CC	1.3	Transmission	M/T
Fuel Type	Gas	Type of Body	Sedan
Colour	Red Mica Metallic

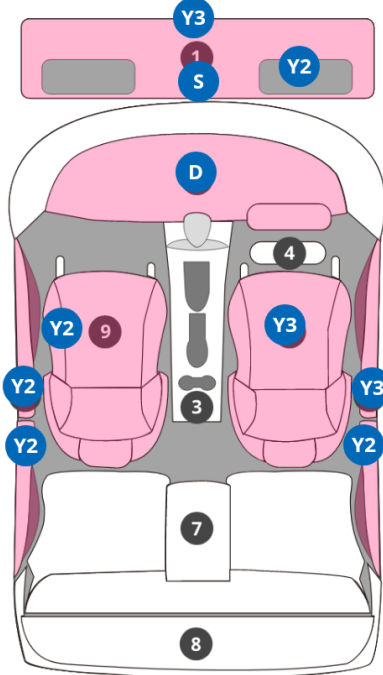
<p>a : Cut, Fray d : Loose, Deformed k : Animal Hair s : Smell t : Cigarette Burns x : Defective y : Stain</p>

<p>A : Scratch AU : Scratch & Dent B : Modified C : Corrosion G : Stone chip P : Faded S : Rust SC : Rust & Corrosion U : Dent X : Defective Y : Crack, Gap</p>
<p>Remarks Overall Interior - Smell - Yes / Ceiling - Grime - Medium / (R) Front Trim - Grime - Medium / (R) Front Seat - Grime - Medium / (R) Rear Trim - Grime - Small / (L) Rear Trim - Grime - Small / (L) Front Trim - Grime - Small / (L) Front Seat - Grime - Small / Dashboard - Traces of Adhesive Tape - Yes / Sunvisor, Sunglass Holder - Grime - Small</p>	<p>Remarks (R) Rear Door - Repair Traces - Yes / (L) Mirror - Scratch - Small / (L) Front Fender, Molding - Scratch - Medium / (R) Front Wheel, Cover - Cap Missing - Yes / (R) Mirror - Scratch - Small / (R) Front Door, Molding - Scratch - Minimal / (R) Rear Door, Molding - Scratch - Large / (R) Rear Fender, Molding - Scratch - Small / Rear Bumper, Lamps, Panels - Scratch & Dent - Large / Trunk Hood, Rear Gate - Dent - Minimal / (L) Rear Fender, Molding - Scratch - Small / (L) Front Door, Molding - Scratch - Small / Front Bumper, Grille, Lamps - Scratch & Dent - Medium / (L) Rear Door, Molding - Scratch & Dent - Minimal</p>
