General Information

Make	Toyota	Model	Vios
YOM	2018	Odo Meter Reading	77,334
Registration No.	DAD4296	Chassis No.	PA1B13F31J4062966
CC	1.3	Transmission	M/T
Fuel Type	Gas	Type of Body	Sedan
Colour	Black

Body / Panel Condition

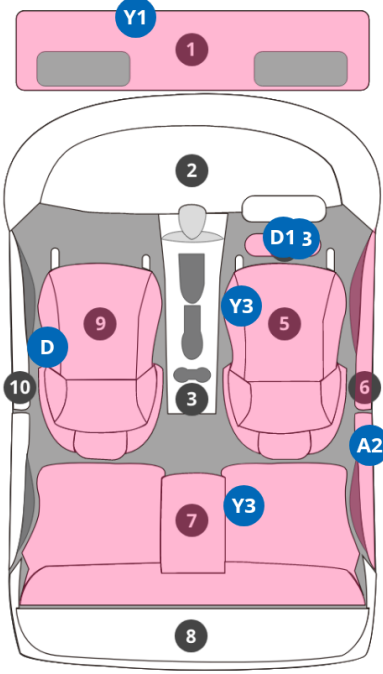
Interior Evaluation : C	Exterior Evaluation : E

<p>a : Cut, Fray d : Loose, Deformed k : Animal Hair s : Smell t : Cigarette Burns x : Defective y : Stain</p>

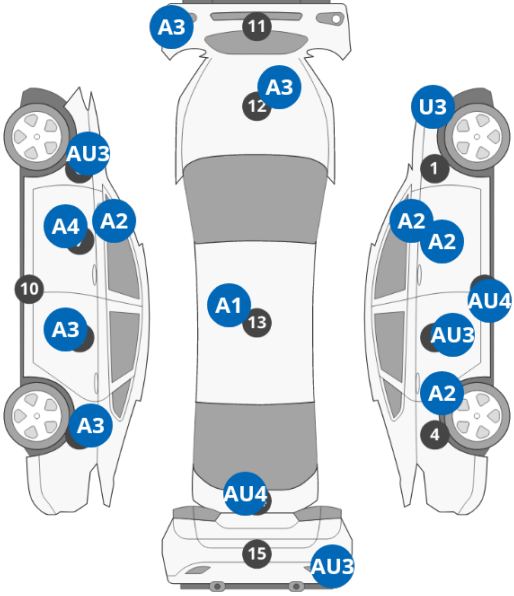
<p>A : Scratch AU : Scratch & Dent B : Modified C : Corrosion G : Stone chip P : Faded S : Rust SC : Rust & Corrosion U : Dent X : Defective Y : Crack, Gap</p>
<p>Remarks Rear Seat - Grime - Medium / (R) Front Seat - Grime - Medium / (L) Front Floor Mat - Cut, Crack - Medium / Carpet - Worked - Minimal / Ceiling - Grime - Minimal / Overall Interior - Worn as per age - Yes / (L) Front Seat - Worn - Yes / (R) Rear Trim - Cut, Crack - Small</p>	<p>Remarks (R) Front Fender, Molding - Dent - Medium / (R) Mirror - Scratch - Small / (L) Mirror - Scratch - Small / Trunk Hood, Rear Gate - Scratch & Dent - Large / Rear Bumper, Lamps, Panels - Scratch & Dent - Medium / (R) Step, In-panel, Side Spoiler - Scratch & Dent - Large / (R) Front Door, Molding - Scratch - Small / (R) Rear Door, Molding - Scratch & Dent - Medium / (L) Rear Fender, Molding - Scratch - Medium / (L) Rear Door, Molding - Scratch - Medium / (L) Front Door, Molding - Scratch - Large / (L) Front Fender, Molding - Scratch & Dent - Medium / Front Bumper, Grille, Lamps - Scratch - Medium / Bonnet, Headlight - Scratch - Medium / Roof - Scratch - Minimal / (R) Rear Fender, Molding - Scratch - Small</p>
