## General Information

| Make | Toyota | Model | Alphard |

## Body / Panel Condition

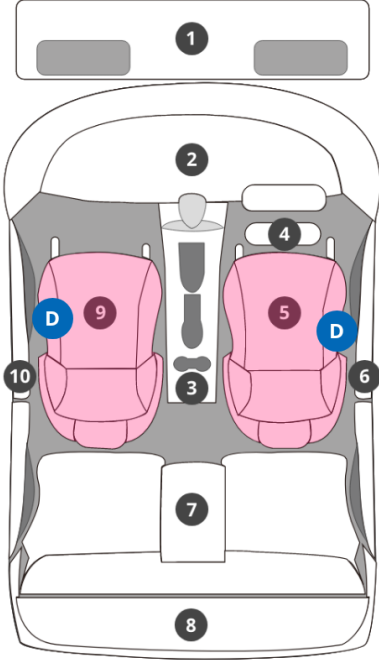
| Interior Evaluation : <span style="color: red;">C</span> | Exterior Evaluation : <span style="color: red;">C</span> |
| <p><b>Remarks</b></p> <p>Overall Interior - Worn as per age - Yes / (L) Front Seat - Worn - Yes / (R) Front Seat - Worn - Yes</p> | <p><b>Remarks</b></p> <p>(R) Front Fender, Molding - Scratch - Minimal / (R) Mirror - Scratch - Small / (R) Step, In-panel, Side Spoiler - Scratch - Small / (R) Rear Door, Molding - Scratch - Minimal / (R) Front Door, Molding - Scratch - Minimal / (R) Rear Fender, Molding - Scratch - Minimal / Rear Bumper, Lamps, Panels - Dent - Medium / Trunk Hood, Rear Gate - Scratch - Minimal / (L) Rear Fender, Molding - Scratch - Minimal / (L) Rear Door, Molding - Scratch - Small / (L) Front Door, Molding - Scratch - Small / (L) Mirror - Scratch - Minimal / (L) Front Fender, Molding - Scratch - Minimal / Front Bumper, Grille, Lamps - Scratch &amp; Dent - Medium / Bonnet, Headlight - Scratch - Small / Roof - Scratch &amp; Dent - Small</p> |
