General Information

Make	Toyota	Model	Vios
YOM	2025	Odo Meter Reading	1,293
Registration No.	NHU7209	Chassis No.	PA1B18F36R4276716
CC	1.3	Transmission	CVT
Fuel Type	Gas	Type of Body	Sedan
Colour	Blue

Body / Panel Condition

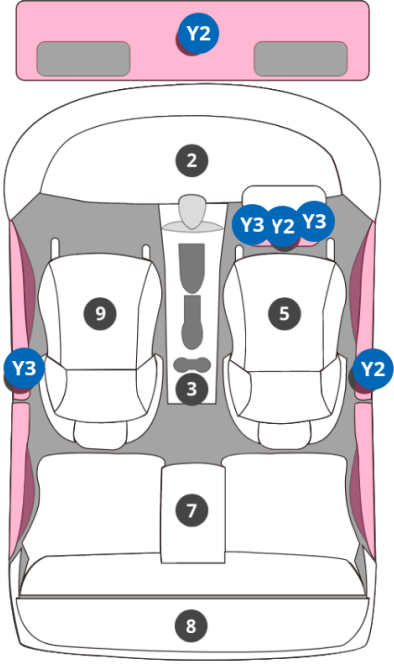
Interior Evaluation : B	Exterior Evaluation : B

<p>a : Cut, Fray d : Loose, Deformed k : Animal Hair s : Smell t : Cigarette Burns x : Defective y : Stain</p>

<p>A : Scratch AU : Scratch & Dent B : Modified C : Corrosion G : Stone chip P : Faded S : Rust SC : Rust & Corrosion U : Dent X : Defective Y : Crack, Gap</p>
<p>Remarks Ceiling - Grime - Small / (R) Front Trim - Grime - Small / (R) Front Floor Mat - Grime - Medium / Mat Other - Grime - Small / (L) Front Trim - Grime - Medium / (L) Front Floor Mat - Grime - Medium</p>	<p>Remarks (L) Rear Door, Molding - Scratch & Dent - Medium / (L) Step, In-panel, Side Spoiler - Scratch & Dent - Small / (L) Front Door, Molding - Scratch & Dent - Small</p>
Frame Evaluation : A	Functional Evaluation : A
<p>Remarks Defects not found</p>	<p>Remarks Defects not found</p>
