## General Information

| Make | Toyota | Model | Vios |
| YOM | 2018 | Odo Meter Reading | 37,320 |
| Registration No. | DAL9009 | Chassis No. | PA1B13F33J4062967 |

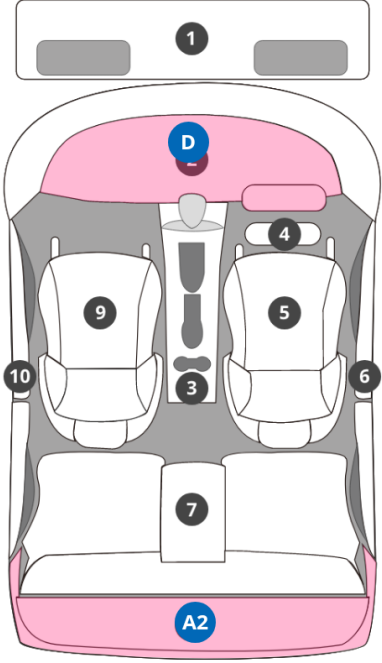
| Interior Evaluation : <b>A</b> | Exterior Evaluation : <b>C</b> |
|---|---|
| <b>Remarks</b><br>Trunk Room - Worn, Scratch, Cut, Crack - Small /<br>Dashboard - Traces of Adhesive Tape - Yes | <b>Remarks</b><br>Trunk Hood, Rear Gate - Repair Traces - Yes / Front Bumper, Grille, Lamps - Scratch - Small / Bonnet, Headlight - Scratch - Small / Rear Bumper, Lamps, Panels - Scratch - Small / (R) Rear Wheel, Cover - Scratch, Corrosion - Small / (R) Front Wheel, Cover - Scratch, Corrosion - Small / (L) Rear Wheel, Cover - Scratch, Corrosion - Small / (L) Front Wheel, Cover - Scratch, Corrosion - Small / Overall Exterior - Faded(Color, Gloss) - Yes |
