General Information

Make	Toyota	Model	Fortuner
YOM	2019	Odo Meter Reading	66,134
Registration No.	DBA5673	Chassis No.	MHFGB8GS1K0901495
CC	2.4	Transmission	A/T
Fuel Type	Diesel	Type of Body	SUV
Colour	Brown

Body / Panel Condition

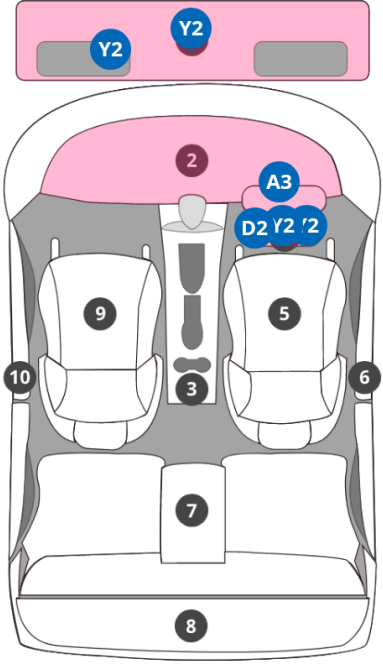
Interior Evaluation : B	Exterior Evaluation : C

<p>a : Cut, Fray d : Loose, Deformed k : Animal Hair s : Smell t : Cigarette Burns x : Defective y : Stain</p>

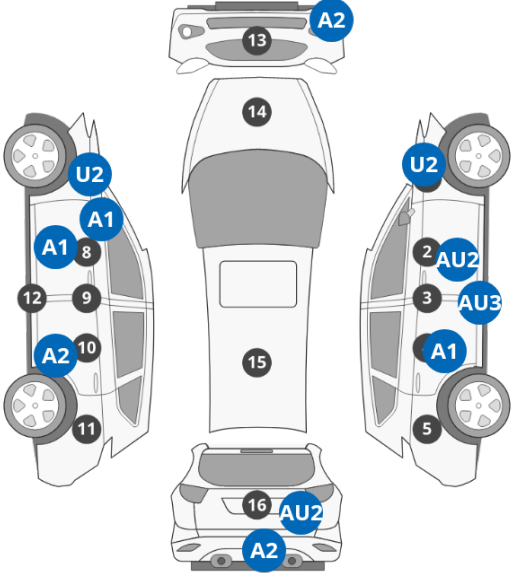
<p>A : Scratch AU : Scratch & Dent B : Modified C : Corrosion G : Stone chip P : Faded S : Rust SC : Rust & Corrosion U : Dent X : Defective Y : Crack, Gap</p>
<p>Remarks (R) Front Floor Mat - Grime - Small / Ceiling - Grime - Small / Mat Other - Grime - Small / (L) Front Floor Mat - Worked - Small / Sunvisor, Sunglass Holder - Grime - Small / Steering Wheel - Worn, Peel, Crack - Medium</p>	<p>Remarks (L) Rear Door, Molding - Scratch - Small / (L) Mirror - Scratch - Minimal / (L) Front Door, Molding - Scratch - Minimal / (L) Front Fender, Molding - Dent - Small / (R) Front Fender, Molding - Dent - Small / Front Bumper, Grille, Lamps - Scratch - Small / (R) Front Door, Molding - Scratch & Dent - Small / (R) Step, In-panel, Side Spoiler - Scratch & Dent - Medium / (R) Rear Door, Molding - Scratch - Minimal / Trunk Hood, Rear Gate - Scratch & Dent - Small / Rear Bumper, Lamps, Panels - Scratch - Small</p>
