General Information

Make	Lexus	Model	ES
YOM	2020	Odo Meter Reading	47,994
Registration No.	DBA3162	Chassis No.	JTHBZ1B10L201067
CC	3.5	Transmission	A/T
Fuel Type	Gas	Type of Body	Sedan
Colour	Blue

Body / Panel Condition

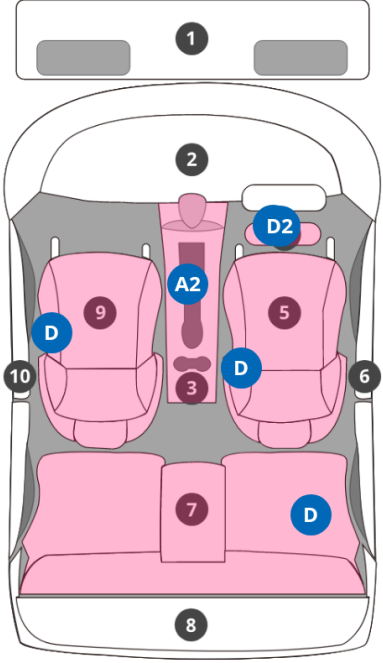
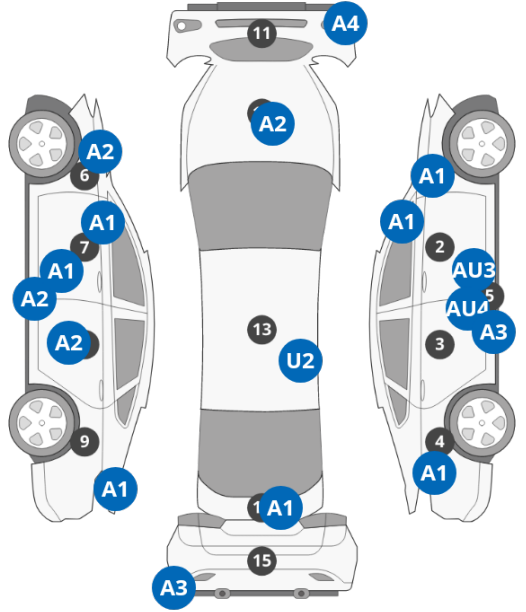
Interior Evaluation :	B	Exterior Evaluation :	E

<p>a : Cut, Fray d : Loose, Deformed k : Animal Hair s : Smell t : Cigarette Burns x : Defective y : Stain</p>		<p>A : Scratch AU : Scratch & Dent B : Modified C : Corrosion G : Stone chip P : Faded S : Rust SC : Rust & Corrosion U : Dent X : Defective Y : Crack, Gap</p>	
<p>Remarks Rear Seat - Worn - Yes / (R) Front Seat - Worn - Yes / Carpet - Worn, Scratch, Cut, Crack - Minimal / (L) Front Seat - Worn - Yes / (L) Front Floor Mat - Worked - Small / Knobs - Worn, Peel, Crack - Small</p>		<p>Remarks Roof - Repair Traces - Yes / (R) Front Fender, Molding - Scratch - Minimal / (R) Mirror - Scratch - Minimal / (R) Front Door, Molding - Scratch & Dent - Medium / (R) Rear Door, Molding - Scratch & Dent - Large / (R) Step, In-panel, Side Spoiler - Scratch - Medium / (R) Rear Fender, Molding - Scratch - Minimal / Rear Bumper, Lamps, Panels - Scratch - Medium / Trunk Hood, Rear Gate - Scratch - Minimal / (L) Rear Fender, Molding - Scratch - Minimal / (L) Step, In-panel, Side Spoiler - Scratch - Small / (L) Rear Door, Molding - Scratch - Small / (L) Front Door, Molding - Scratch - Minimal / (L) Mirror - Scratch - Minimal / (L) Front Fender, Molding - Scratch - Small / Front Bumper, Grille, Lamps - Scratch - Large / Bonnet, Headlight - Scratch - Small / Roof - Dent - Small</p>
