## General Information

| Make | Toyota | Model | Vios |
| Registration No. | CCD2310 | Chassis No. | PA1B18F3XR4244948 |

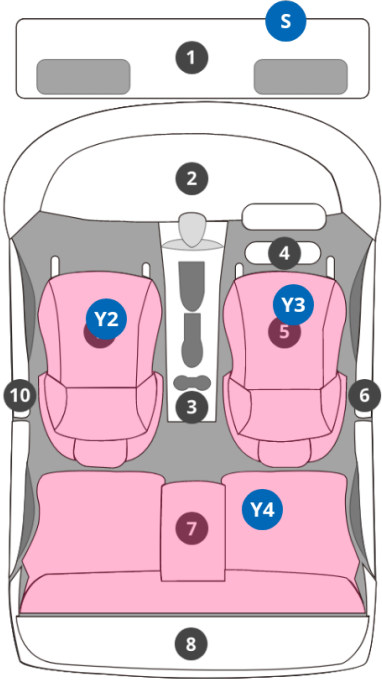
| Interior Evaluation : <span style="color: red;">C</span> | Exterior Evaluation : <span style="color: red;">C</span> |
|---|---|
| <b>Remarks</b><br>Rear Seat - Grime - Large / (R) Front Seat - Grime - Medium / Overall Interior - Smell - Yes / (L) Front Seat - Grime - Small | <b>Remarks</b><br>Trunk Hood, Rear Gate - Repair Traces - Yes / Trunk Hood, Rear Gate - Repair mark - Yes / (R) Rear Fender, Molding - Scratch - Small / (R) Rear Door, Molding - Scratch & Dent - Minimal / (R) Front Door, Molding - Scratch - Small / (R) Front Fender, Molding - Scratch - Minimal / Member (Bolted) - Dent - Yes / (L) Rear Door, Molding - Scratch & Dent - Small / (L) Front Door, Molding - Scratch - Small / Roof - Scratch - Small / (L) Rear Fender, Molding - Scratch - Small / Trunk Hood, Rear Gate - Crack, Gap - Medium / Rear Bumper, Lamps, Panels - Scratch - Small / Bonnet, Headlight - Scratch - Small / Front Bumper, Grille, Lamps - Scratch - Small / (L) Step, In-panel, Side Spoiler - Scratch & Dent - Small / (R) Step, In-panel, Side Spoiler - Scratch & Dent - Small |
