## General Information

| Make | Toyota | Model | Vios |
| Registration No. | DBN4714 | Chassis No. | PA1B18F31P4232135 |

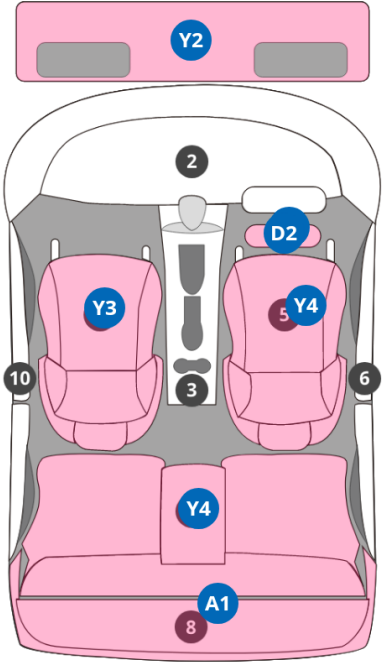
| Interior Evaluation : <span style="color: red; font-weight: bold;">C</span> | Exterior Evaluation : <span style="color: red; font-weight: bold;">B</span> |
|---|---|
| <b>Remarks</b><br>Trunk Room - Worn, Scratch, Cut, Crack - Minimal / Rear Seat - Grime - Large / (R) Front Seat - Grime - Large / (R) Front Floor Mat - Grime - Small / Ceiling - Grime - Small / (L) Front Seat - Grime - Medium / (L) Front Floor Mat - Worked - Small | <b>Remarks</b><br>(R) Front Fender, Molding - Scratch - Minimal / (R) Front Door, Molding - Scratch & Dent - Minimal / (R) Mirror - Scratch - Minimal / (R) Rear Door, Molding - Scratch - Minimal / (R) Rear Fender, Molding - Scratch - Minimal / Rear Bumper, Lamps, Panels - Scratch - Medium / Trunk Hood, Rear Gate - Scratch - Small / (L) Rear Fender, Molding - Scratch - Minimal / (L) Rear Door, Molding - Scratch - Minimal / (L) Front Door, Molding - Scratch - Minimal / (L) Mirror - Scratch - Minimal / (L) Front Fender, Molding - Dent - Minimal / Front Bumper, Grille, Lamps - Scratch - Medium / Bonnet, Headlight - Scratch - Minimal / Roof - Scratch - Minimal |
