## General Information

| Make | Toyota | Model | Wigo |
| YOM | 2024 | Odo Meter Reading | 15,082 |

## Body / Panel Condition

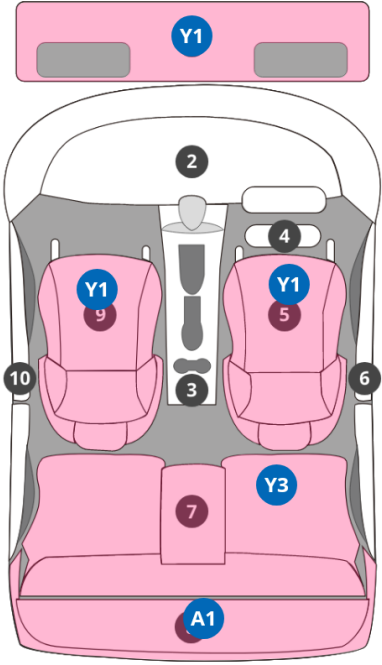
| Interior Evaluation : <b>B</b> | Exterior Evaluation : <b>D</b> |
|---|---|
| <p><b>a</b> : Cut, Fray <b>d</b> : Loose, Deformed <b>k</b> : Animal Hair <b>s</b> : Smell <b>t</b> : Cigarette Burns <b>x</b> : Defective <b>y</b> : Stain</p> | <p><b>A</b> : Scratch <b>AU</b> : Scratch &amp; Dent <b>B</b> : Modified <b>C</b> : Corrosion <b>G</b> : Stone chip <b>P</b> : Faded <b>S</b> : Rust <b>SC</b> : Rust &amp; Corrosion <b>U</b> : Dent <b>X</b> : Defective <b>Y</b> : Crack, Gap</p> |
| <p><b>Remarks</b><br/>Trunk Room - Worn, Scratch, Cut, Crack - Minimal / Rear Seat - Grime - Medium / (R) Front Seat - Grime - Minimal / (L) Front Seat - Grime - Minimal / Ceiling - Grime - Minimal</p> | <p><b>Remarks</b><br/>(R) Front Fender, Molding - Scratch - Small / (R) Front Door, Molding - Scratch - Medium / (R) Rear Door, Molding - Scratch - Medium / (R) Rear Fender, Molding - Scratch - Small / Rear Bumper, Lamps, Panels - Scratch - Small / Trunk Hood, Rear Gate - Dent - Medium / (L) Rear Fender, Molding - Scratch - Minimal / (L) Rear Door, Molding - Scratch - Minimal / (L) Front Door, Molding - Scratch - Small / (L) Front Fender, Molding - Scratch - Small / Front Bumper, Grille, Lamps - Scratch - Medium / Roof - Scratch - Small / Bonnet, Headlight - Scratch - Minimal / (R) Mirror - Scratch - Small</p> |
