## General Information

| Make | Toyota | Model | Vios |

## Body / Panel Condition

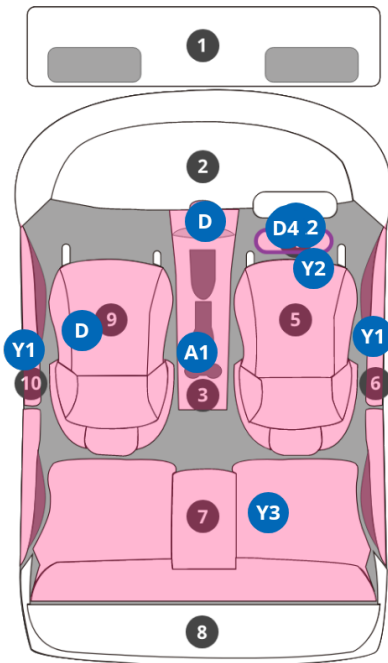
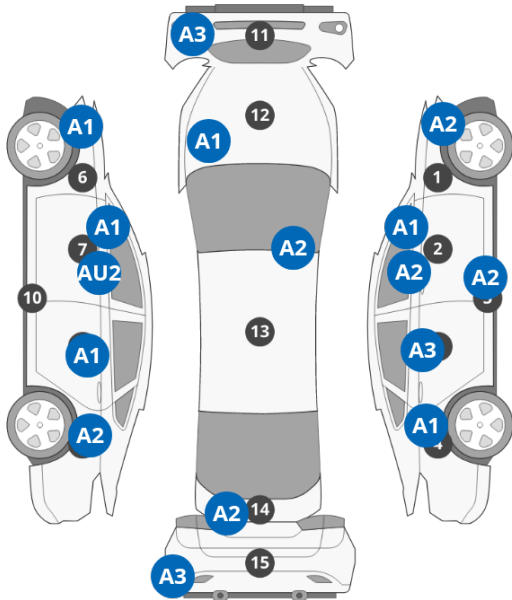
| Interior Evaluation : C | | Exterior Evaluation : C | |
|---|--|---|--|
| <p>a : Cut, Fray d : Loose, Deformed k : Animal Hair s : Smell t : Cigarette Burns x : Defective y : Stain</p> | | <p>A : Scratch AU : Scratch &amp; Dent B : Modified C : Corrosion G : Stone chip P : Faded S : Rust SC : Rust &amp; Corrosion U : Dent X : Defective Y : Crack, Gap</p> | |
| <p><b>Remarks</b></p> <p>Mat Other - Missing - Yes / (R) Front Floor Mat - Missing - Yes / Rear Seat - Grime - Medium / (L) Front Seat - Worn - Yes / (R) Front Seat - Grime - Small / (R) Front Trim - Grime - Minimal / (L) Front Trim - Grime - Minimal / Carpet - Worked - Minimal / (L) Front Floor Mat - Cut, Crack - Small / (L) Front Floor Mat - Worked - Large / Console, Switches, Vents - Traces of Adhesive Tape - Yes / Console, Switches, Vents - Worn, Scratch, Cut, Crack - Minimal</p> | | <p><b>Remarks</b></p> <p>(R) Front Fender, Molding - Scratch - Small / (R) Mirror - Scratch - Minimal / (R) Rear Door, Molding - Scratch - Medium / (R) Step, In-panel, Side Spoiler - Scratch - Small / (R) Front Door, Molding - Scratch - Small / (R) Rear Fender, Molding - Scratch - Minimal / Rear Bumper, Lamps, Panels - Scratch - Medium / Trunk Hood, Rear Gate - Scratch - Small / (L) Rear Fender, Molding - Scratch - Small / (L) Front Door, Molding - Scratch &amp; Dent - Small / (L) Rear Door, Molding - Scratch - Minimal / (L) Mirror - Scratch - Minimal / (L) Front Fender, Molding - Scratch - Minimal / Front Bumper, Grille, Lamps - Scratch - Medium / Bonnet, Headlight - Scratch - Minimal / Roof - Scratch - Small</p> | |
