## General Information

| Make | Toyota | Model | Vios |

## Body / Panel Condition

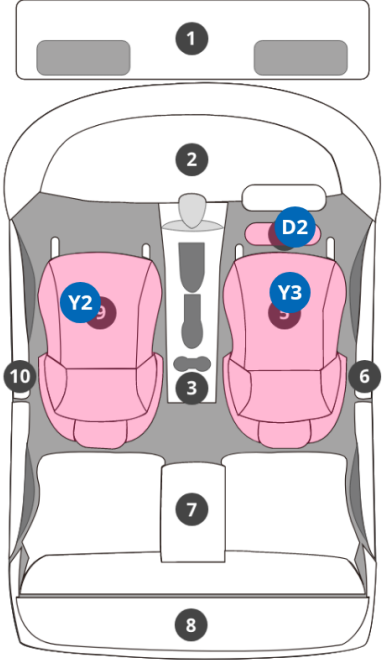
| Interior Evaluation : <b>B</b> | Exterior Evaluation : <b>C</b> |
|---|---|
| <p><b>Remarks</b><br/>(R) Front Seat - Grime - Medium / (L) Front Seat - Grime - Small / (L) Front Floor Mat - Worked - Small</p> | <p><b>Remarks</b><br/>(L) Front Fender - Repair Traces - Yes / (R) Front Fender, Molding - Scratch - Small / (R) Front Door, Molding - Scratch - Minimal / (R) Rear Door, Molding - Scratch - Small / (R) Rear Fender, Molding - Scratch - Minimal / Rear Bumper, Lamps, Panels - Scratch - Small / Trunk Hood, Rear Gate - Scratch &amp; Dent - Small / (L) Rear Fender, Molding - Scratch &amp; Dent - Medium / (L) Front Fender, Molding - Repair mark - Yes / (L) Rear Door, Molding - Scratch - Minimal / (L) Front Door, Molding - Scratch - Small / (L) Front Fender, Molding - Scratch - Small / Bonnet, Headlight - Scratch - Small / Front Bumper, Grille, Lamps - Scratch - Small / Member (Bolted) - Dent - Yes / Roof - Scratch - Minimal</p> |

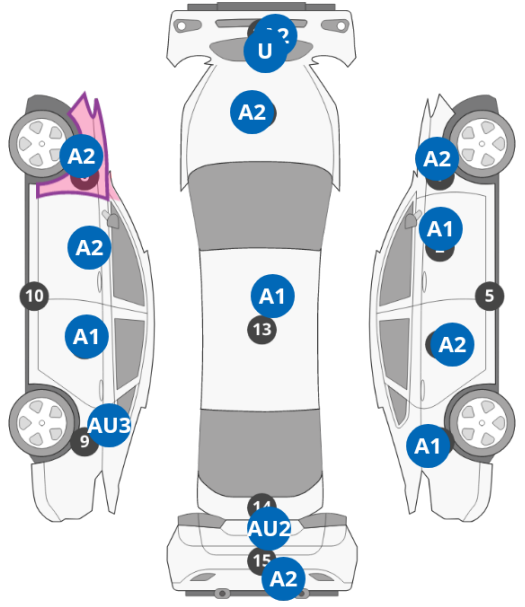
with LTO plate and Sparetire, Jack and Incomplete Tools. no warranty booklet, scratch headlight and tail light.
