## General Information

| Make | Suzuki | Model | Dzire |
| Registration No. | NHD1170 | Chassis No. | MBHZF63S1PG230955 |

## Body / Panel Condition

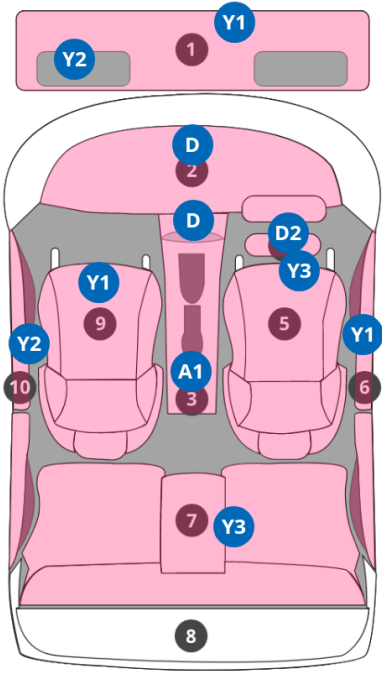
| Interior Evaluation : <b>C</b> | Exterior Evaluation : <b>E</b> |
| <b>Remarks</b><br>(R) Front Seat - Grime - Medium / Rear Seat - Grime - Medium / (L) Front Floor Mat - Worked - Small / (L) Front Trim - Grime - Small / (R) Front Trim - Grime - Minimal / Console, Switches, Vents - Traces of Adhesive Tape - Yes / Console, Switches, Vents - Worn, Scratch, Cut, Crack - Minimal / Dashboard - Traces of Adhesive Tape - Yes / Sunvisor, Sunglass Holder - Grime - Small / Ceiling - Grime - Minimal / (L) Front Seat - Grime - Minimal | <b>Remarks</b><br>(R) Front Fender, Molding - Repair mark - Yes / (R) Front Door, Molding - Repair mark - Yes / (R) Rear Door, Molding - Repair mark - Yes / (R) Front Fender, Molding - Scratch & Dent - Large / (R) Front Door, Molding - Scratch & Dent - Medium / (R) Rear Door, Molding - Scratch & Dent - Medium / (R) Rear Fender, Molding - Repair mark - Yes / (R) Rear Fender, Molding - Scratch & Dent - Medium / Rear Bumper, Lamps, Panels - Crack, Gap - Medium / Trunk Hood, Rear Gate - Dent - Small / (L) Rear Fender, Molding - Scratch & Dent - Small / (L) Rear Door, Molding - Repair mark - Yes / (L) Front Door, Molding - Repair mark - Yes / (L) Rear Door, Molding - Scratch - Medium / (L) Front Door, Molding - Scratch & Dent - Large / (L) Mirror - Scratch - Minimal / (L) Front Fender, Molding - Scratch - Small / Front Bumper, Grille, Lamps - Repair mark - Yes / Front Bumper, Grille, Lamps - Scratch & Dent - Large / Bonnet, Headlight - Scratch - Medium / (R) Step, In-panel, Side Spoiler - Scratch & Dent - Medium / (R) Mirror - Scratch - Small / Roof - Scratch - Small |

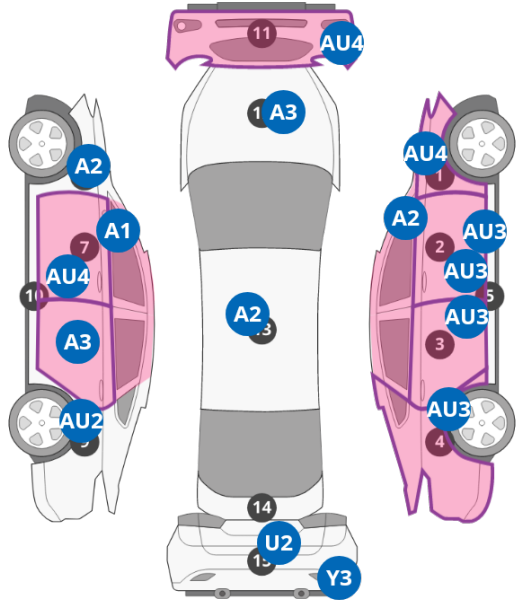
| Inspector Notes |
|---|
| no warranty booklet, no jack and tools, with spare tire and LTO PLATE, scratches on tail light |
